**“HERAKLEOPOLIS MAGNA  
PROJECT”. IHNASYA EL MEDINA,  
BENI SUEF.  
SEASON 2015**

BY MARIA CARMEN PEREZ-DIE  
and Antonio Gomez, Gema Garrido, Antonio Guio, Juan  
Angel Ruiz Sabina y Antonia Moreno

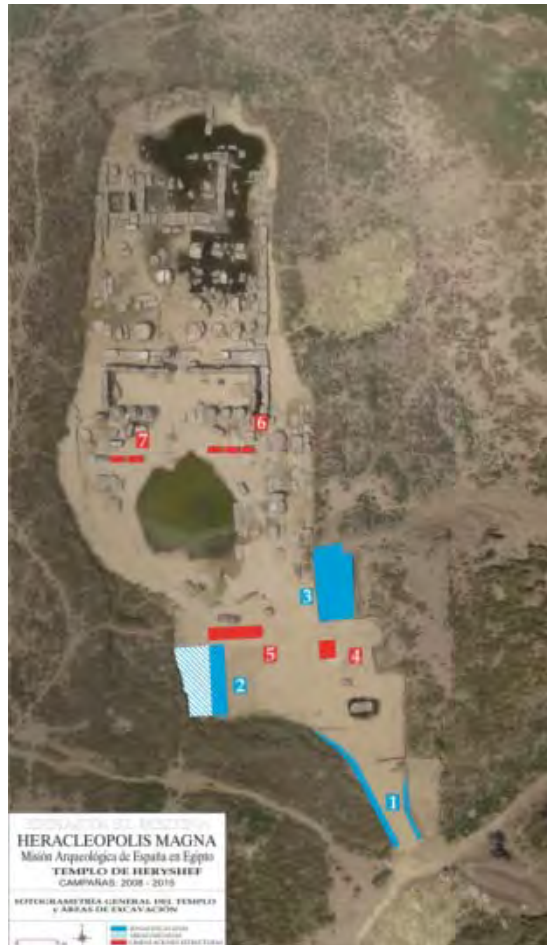
**Photo 1. Zones excavated in the 2015 Season**

**I.1. Excavation** was started of different zones in the south of the Temple (Zones 1 and 2) and work continued in the east of the courtyard (Zone 3). Zone 1 is located at the entrance to the Temple and Zone 2 is in the centre of the courtyard. Both were excavated for the first time in 2015. In Zone 3 the excavation work started in previous years was continued (Photo 1 *in blue*).

**I.2.-** Additionally, **other archaeological interventions** also carried out in this 2015 campaign have provided support for restoration work. These are Zones 4, 5, 6, and 7 (Photo 1 **in red**) which have been selected to build the supports (*mastabas*) on which architectural and sculptural items will be placed, forming part of the open air museum which is being set up in the Temple. It was necessary to check that there were no archaeological remains under the supports.

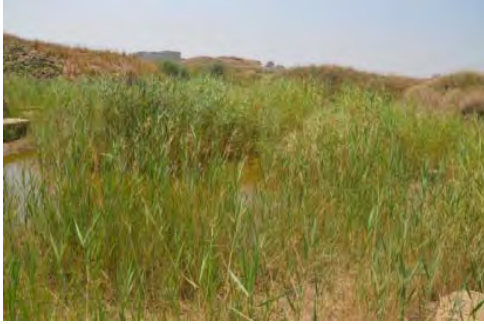
**Work started on the initial clearing of the temple**, to remove all the vegetation cover. (Photos 2a and 2b).

**Photos 2a. Before cleaning**

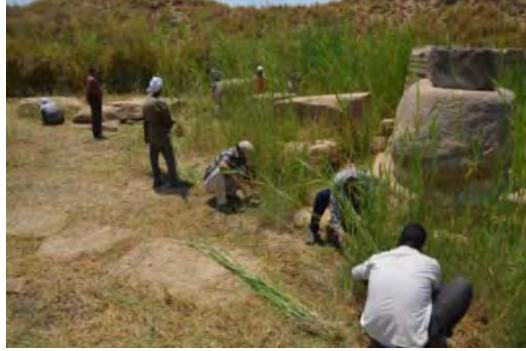
**Photos 2b. Cleaning work**

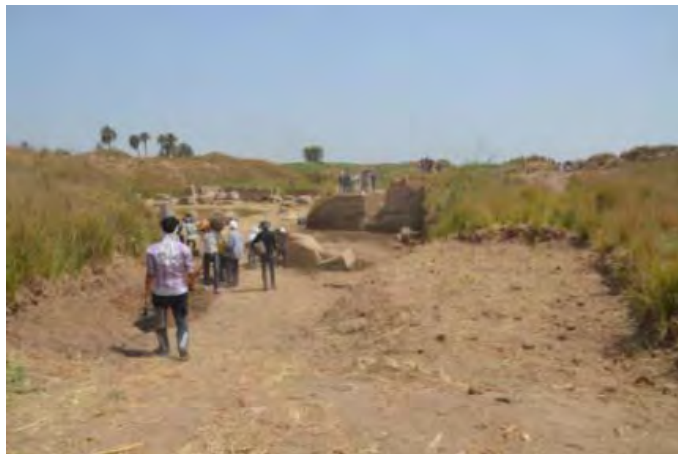
**Photo 3 Zone 1. Temple entrance**

**Zone 1. Extending the entrance to the Temple.** In 2013 excavation started of the east side of the entrance, locating some structures dated to the Roman period. The work in 2015 has focused on removing the fallen earth, which did not contribute any archaeological material. (Photo 3).

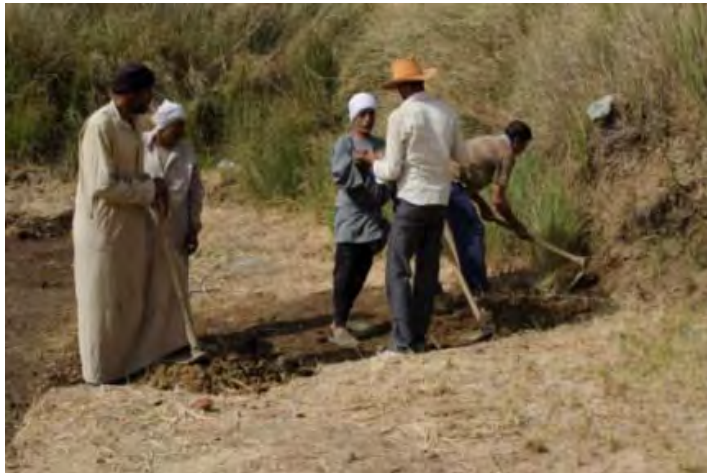
**Photo 4. Zone 2**

This is located in the south of the Temple courtyard. The whole surface of this area was found covered with disturbed earth, fallen onto some sort of severely ruined construction. It was not possible to finish the excavation (Photo 4).

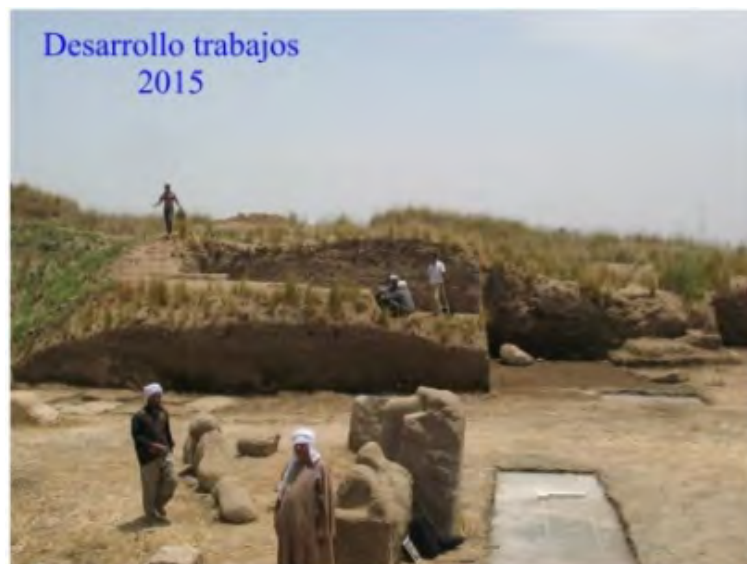
**Photo 5. Zone 3, excavations**

**Zone 3. Excavation of the Temple (continuing work started during the 2012-2013 campaign).** The aim here was to clear this area of the Temple to provide greater visibility and to continue with cleaning the adobe wall which was identified as the enclosure wall of the Temple. The zone where this work was carried out in 2015 was, just as in other previous years, covered with piles of earth and fragments of materials from older excavations (Photo 5).

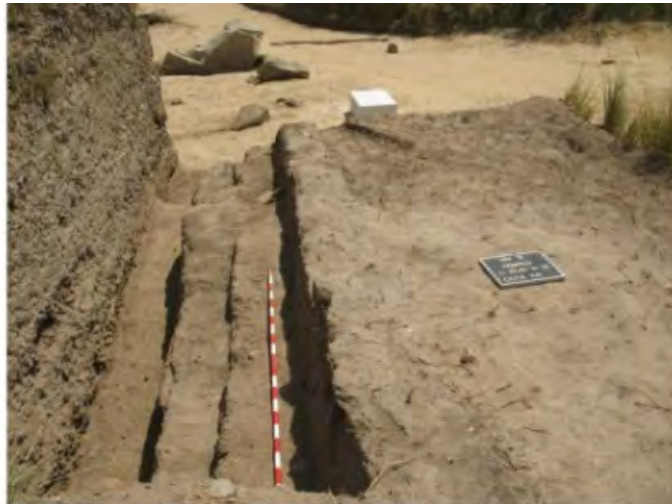
**Photo 6. Zone 3. Adobe wall**

As the excavation progressed, the rest of the adobe wall was found, and although for the moment we do not know its total width, it would seem to be more than 70 cm thick. The wall runs N-S with a length of 8.40 m, decreasing in height towards the South where it is broken and disappears (Photo 6).

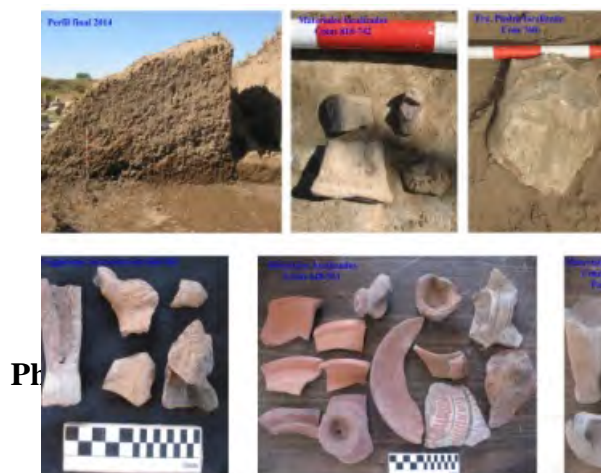
**Photo 7**

The material collected includes remains of iron scoria, and also ordinary pottery (bowls, plates, cups and other tableware, lamps etc.) and pottery kitchenware (storage jars, different types of amphorae etc.); the presence was noted of numerous fragments of African terra-sigillata. Fragments of terracotta figures were also found (Photo 7).

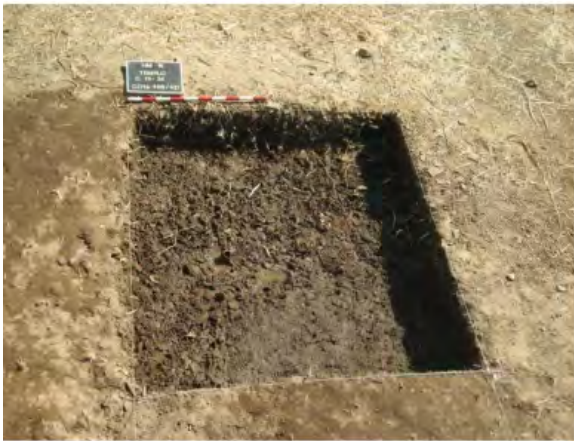
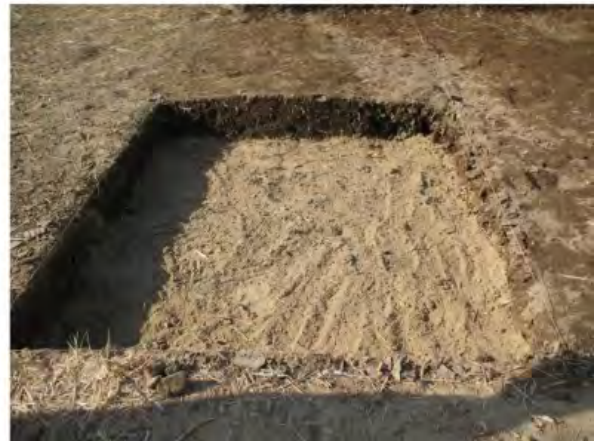
**Photos 8a and 8b. Zone 4**

**Zone 4. Space to install the support (*mastaba*) for the block with inscriptions.** Two different levels were found in this location although no monument was discovered. The excavation had to be abandoned at a depth of 4.85 m. because water was present. It was left covered with sand (Photos 8a and 8b).

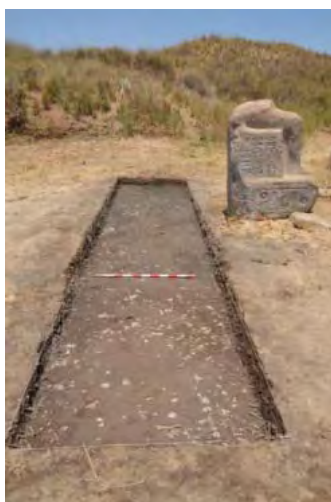
After removing a thick layer of disturbed earth, compact level ground was revealed extending over a large surface area in the south of the courtyard. This ground rests on a layer of mixed broken pottery, mostly from the Roman era. (Photos 9a and 9b).

**Photo 9a Zone 5. Ground**

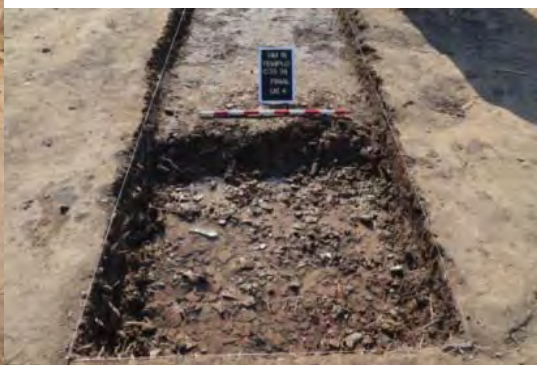
**Photo 9b. Pottery layer**

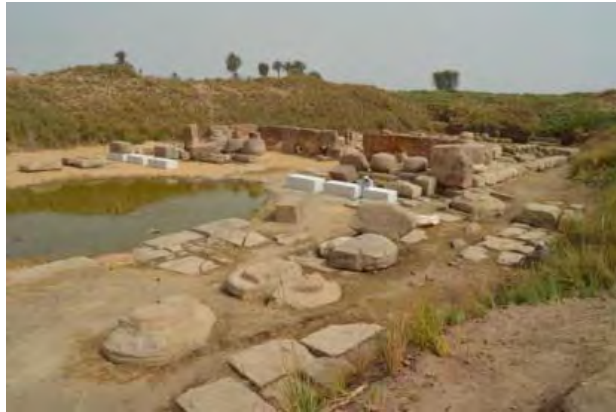
**Zones 6 and 7.** Related to the pedestals to support the architraves. No archaeological remains were found (Photo 10).

**Photo 10. Zones 6 and 7. Pedestals for architraves (*in white*).**

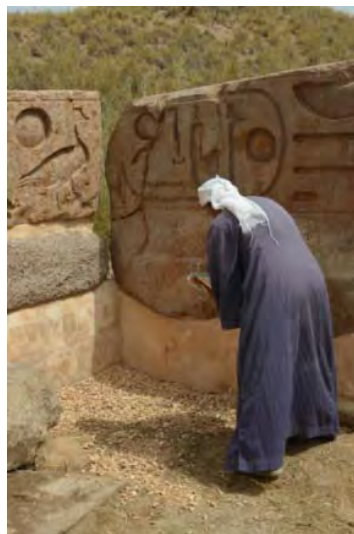
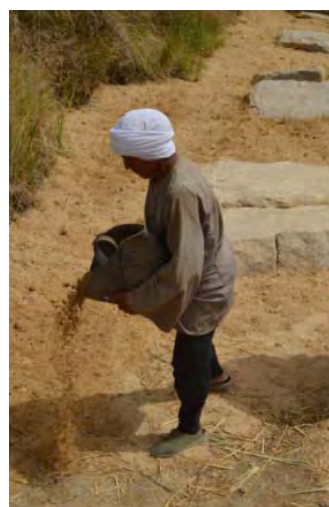
**Photos 11-12 Sand and gravel cover II. –**

Once the work had been completed the whole of the Temple of Heryshef was covered with sand and gravel. Large quantities of sand and gravel were spread, especially in the area in front of the decorated frieze of Ramses II, with the aim of delaying the growth of vegetation. This meant that a clear and orderly view of the temple was obtained, with the precincts and architectural features of the building clearly visible. The low level of the water table also enabled this clear view (Photos 11-12).

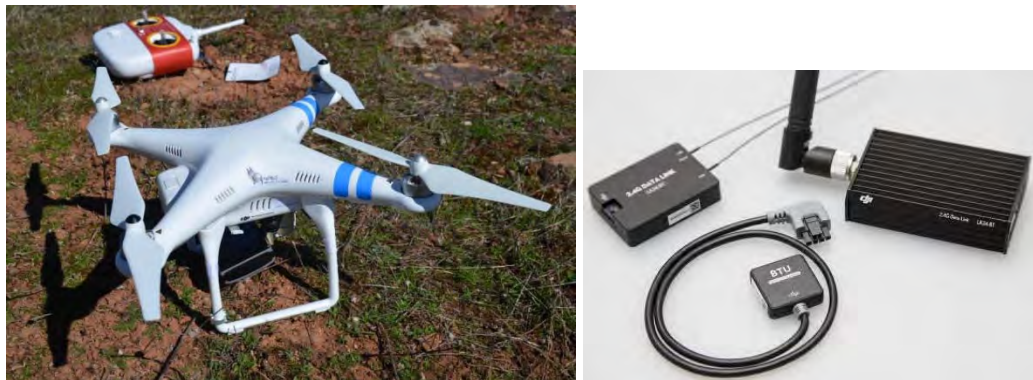
For the Aerial photogrammetry a Phantom 2 drone was used, carrying two types of cameras: a Gopro 3+ with gimbal and mechanical suspension and a Canon Powershot S110, without mechanical suspension. The images were taken in both JPG and RAW.

**Photo 13 a and b. Drone cuadricóptero DJI PHANTOM2 with gimbal zenmuse H3-2D for cameras gopro hero3. And Inhalambric conexions for the control of the Drone.**

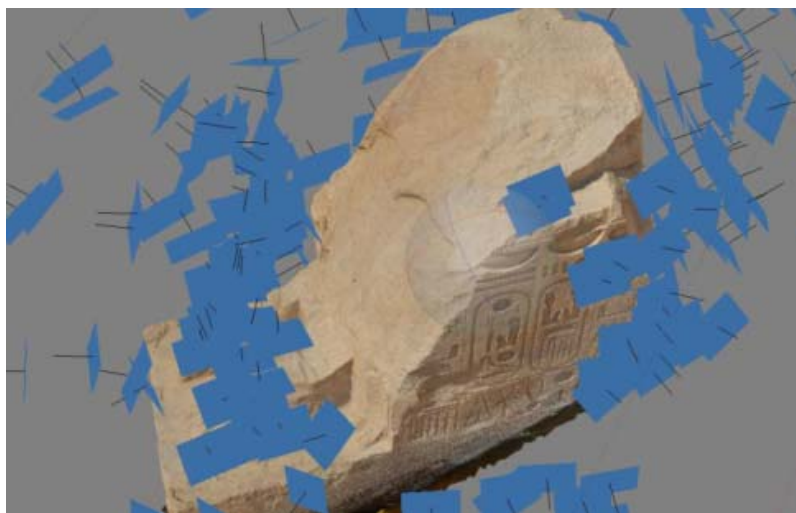
**Photo 14 Series of photos taken by the camera (blue squares) to generate the 3D model of the Colossus found in the Temple of Heryshef**

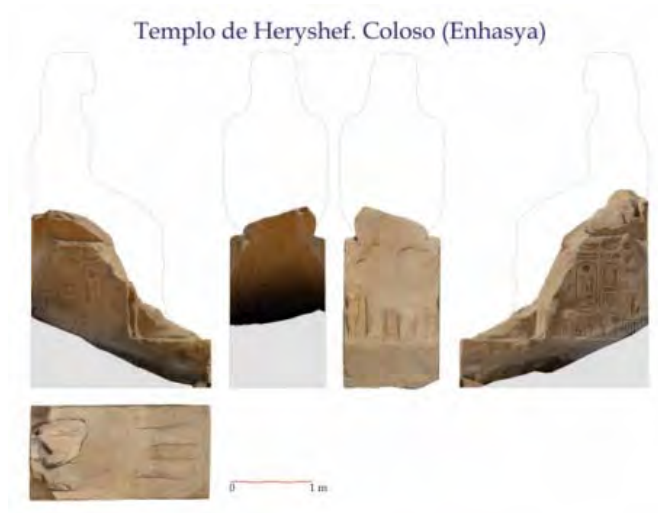
**Photo 15. Colossus of the Temple of Heryshef, from terrestrial photogrammetry**

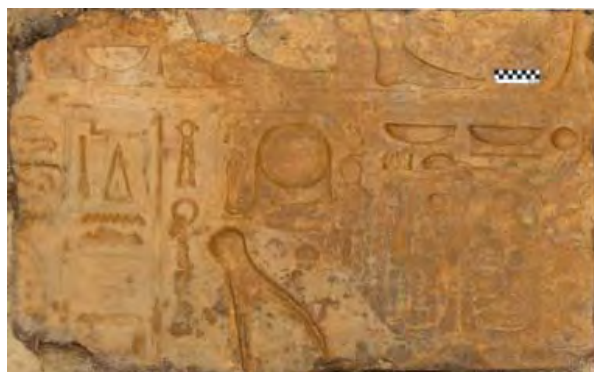
**Photo 16. Photogrammetry of a block reused in the foundations of the Temple**

To document the excavation a digital system using photogrammetry was used for the first time (Photos 14-17). This system is based on generating 3D images, which allow orthophotos to be obtained for developing plans. A tripod was also used to take complementary photographs of all the elevations. This type of documentation is more accurate, but requires more effort, as well the complications caused by the illumination of the objects.

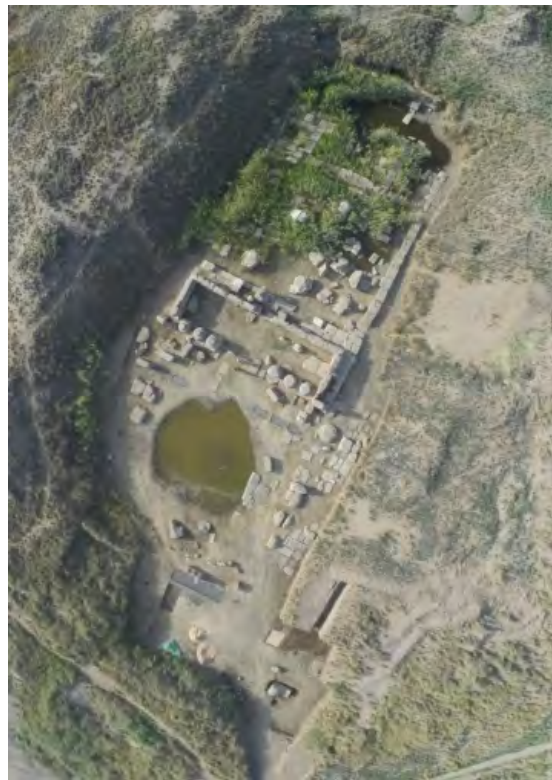
A difficult problem to solve is the presence of surface water as the water table rises at certain times of the year and floods a large part of the monument. This is combined with the growth of weeds and bushes which obstruct the visibility of the site as a whole and which have to be cut every year (Photo 18).

**Photo 18 . Aerial View of the Temple**

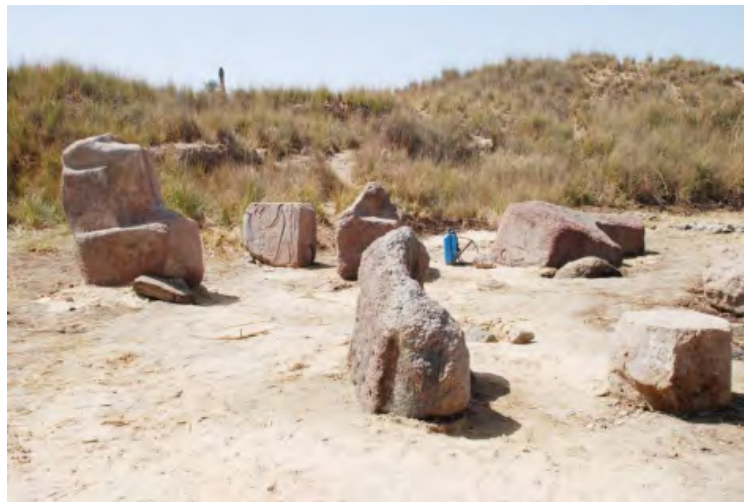
**Photo 19. Sculptures to be relocated**

**III.2.3 Action n° 6 (Determining and defining the definitive location for the decorative elements and sculptures)** has been mostly carried out. The decisions as to the siting of the different elements were made taking into account the possibilities of placing them “in situ” or to the contrary finding the most appropriate place where they can be displayed to advantage and better understood (Photo 19).

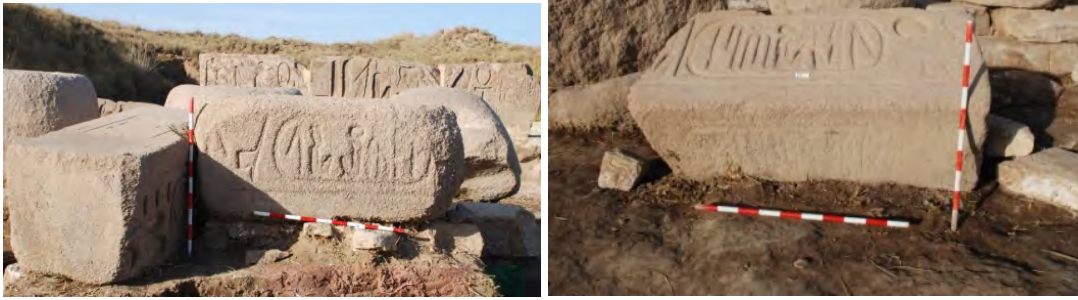
a. - **Architraves.** It is impossible to relocate these in their original raised position resting on the columns as these are currently scattered in museums throughout the world. For this reason, the decision was taken to place them in the courtyard, in front of the original granite bases of the columns, thus directly relating them to their original position (Photos 20 and 21).

**Photos 20 and 21. Fallen architraves in front of the column bases**

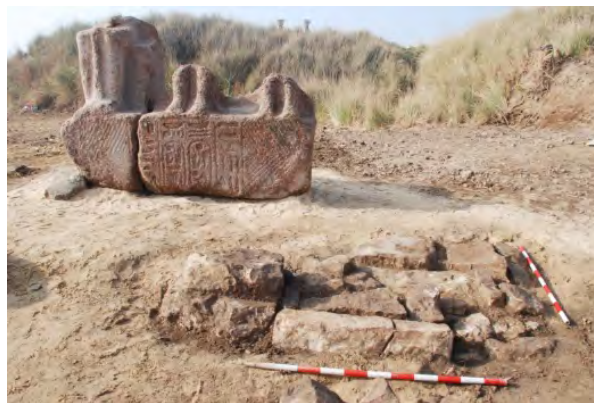
b. - **Fragmented granite triad.** Thanks to Petrie's indications we know where this was originally located, i.e. on a base of stones in the eastern zone of the courtyard access, facing the entrance to the portico. For this reason, we have decided to place this triad behind the base, so as not to hide the original stones (Photos 22 and 23).

**Photo 22. Lower part of the triad together with its original base**

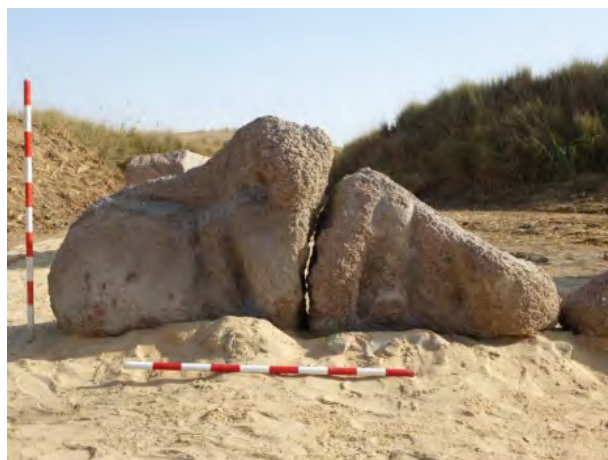
**Photo 23 Triad. Upper part**

The triad will be installed on two pedestals, one with the lower part and the other with the upper part. The central part of the sculpture is missing although it may still be found in future excavations in other zones near the Temple.

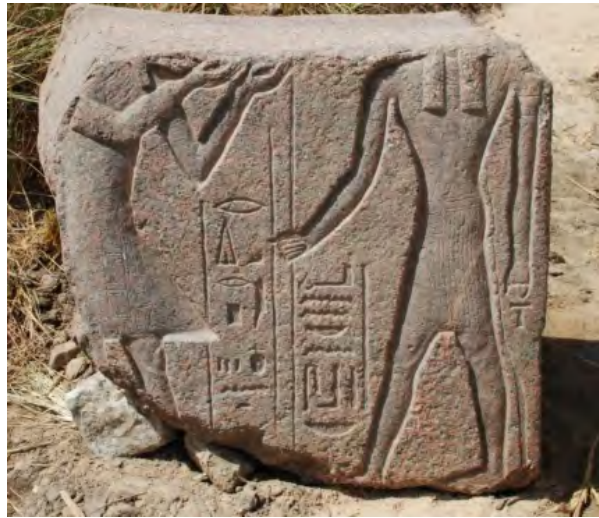
**Photo 24. Item with inscription**

c. - **Inscription with adoration scene**, original location unknown. We have considered placing this near the colossus, to form part of the planned Open-air Museum (Photo 24).

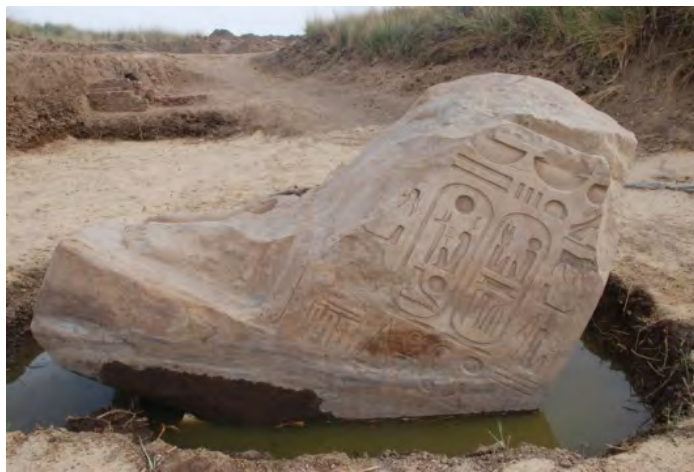
**Photo 25. Colossus of Ramses II**

d. - **Colossus**. Not work on it (Photo 25).

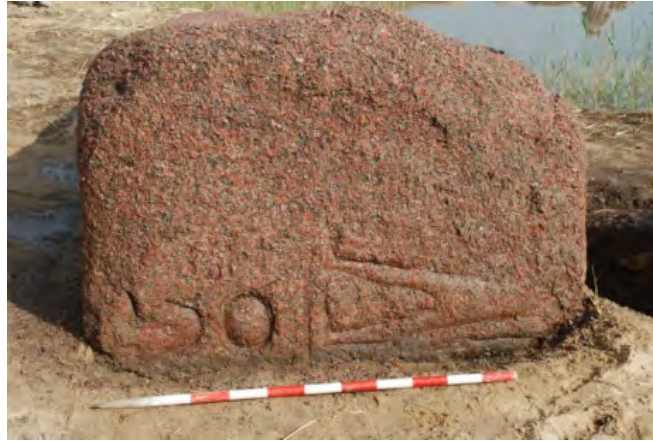
e. - **Large granite stone (door? or pylon)**, fallen, with inscription. Its definitive location will be determined next year. Nevertheless, we consider that it should be placed on the other side of the access door to the courtyard. We will have to take into consideration that it is very near the water and it may have to be displaced slightly (Photo 26).

**Photo 26. Granite stone**

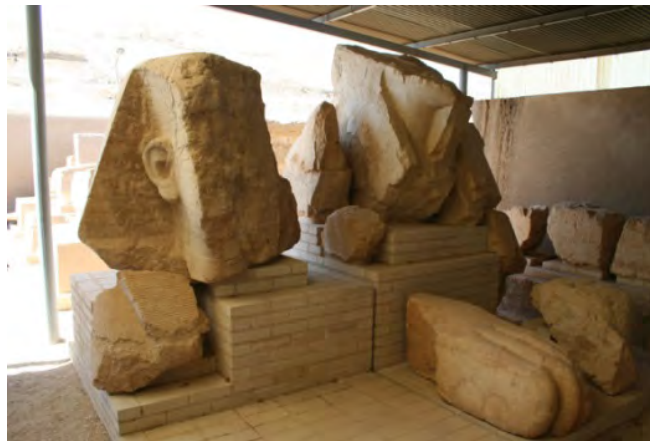
**Photo 27. Temple of Merenptah, Luxor**

Which materials to use to construct these pedestals was considered for a long time. After examining the possibility of building them in stone, or with rendered concrete bricks, it was finally decided to use white bricks, the same solution as used in the Temple of Merenptah in Luxor by the Swiss Archaeological Institute in their Open-air Museum (Photo 27).

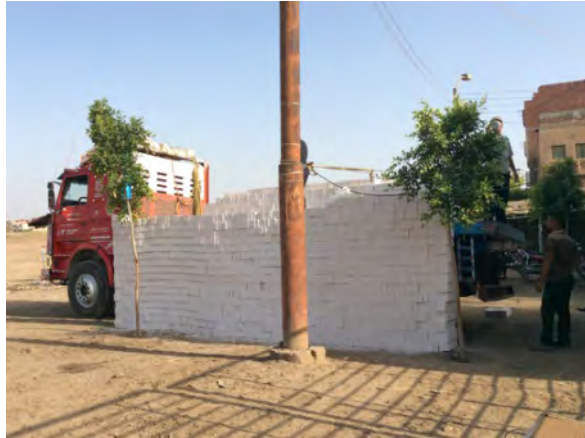
**Photo 28. Transporting the bricks to Ehnasya**

The bricks were brought from Cairo, and some of them have already been used; the rest are deposited in the store of the Spanish Mission in Ehnasya for use in future campaigns. (Photos 28-29).

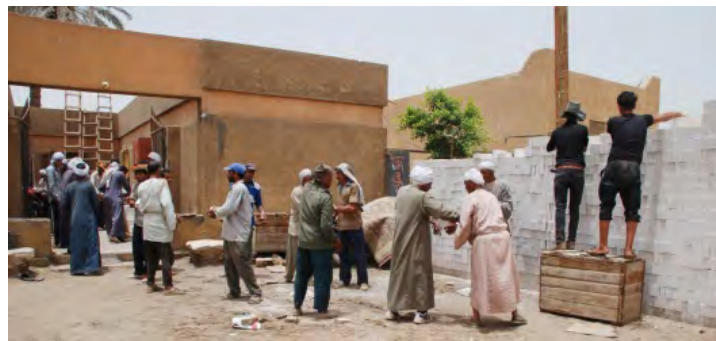
**Photo 29. Transferring the remaining unused bricks to the store.**

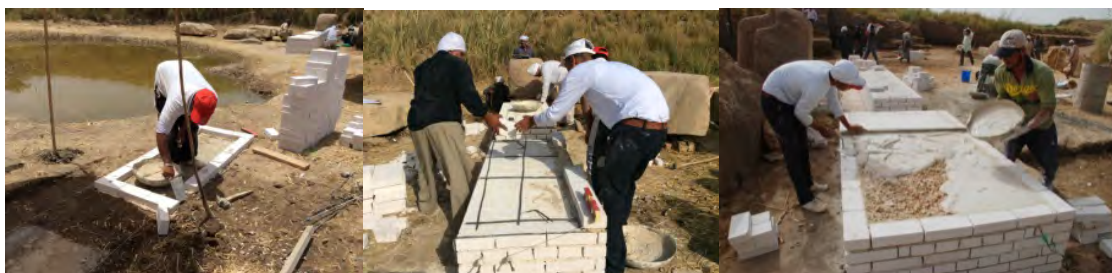
To construct the pedestals (*mastabas*), the bricks were laid alternating headers and stretchers in seven superimposed horizontal courses to ensure they are all the same height; the bricks are joined with a mortar of white cement, sand and pebbles and the pedestal is reinforced with steel mesh at different levels and with plastic sheeting to prevent the water from reaching the upper part and affecting the exhibit when there is a significant rise in the water table. They were then covered with white bricks (Photo 30).

**Photo. 30. Construction process**

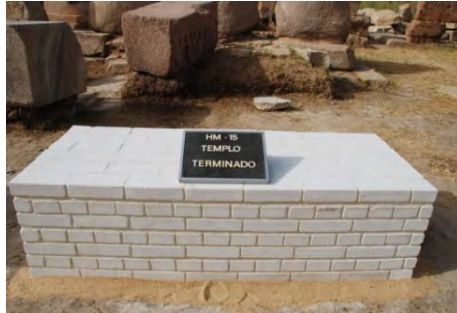
The joints between the bricks have been pointed, unified and smoothed; these pedestals will be painted next year, when the cement has set and dried, to tone in better with the rest of the Temple complex and the colour of its stones, as at present the white is too bright (Photo31).

**Photo 31. Finished pedestal**

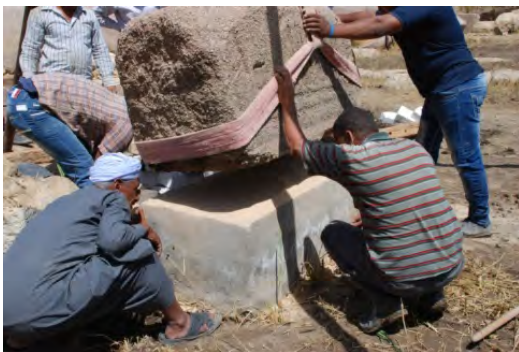
**hoto 32. Placing architrave in 2014**

Placed last year on a concrete pedestal. This has been clad with bricks to unify it with the others (Photos 32-33).

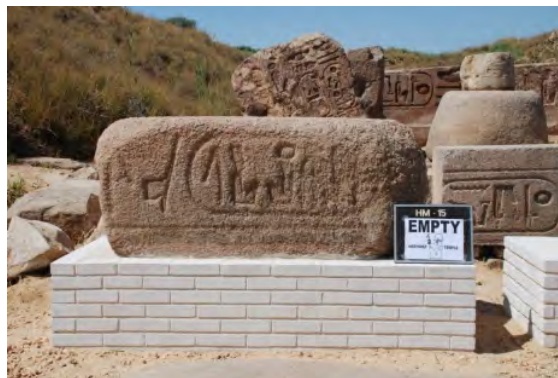
**Photo 33. Architrave in situ 2015**

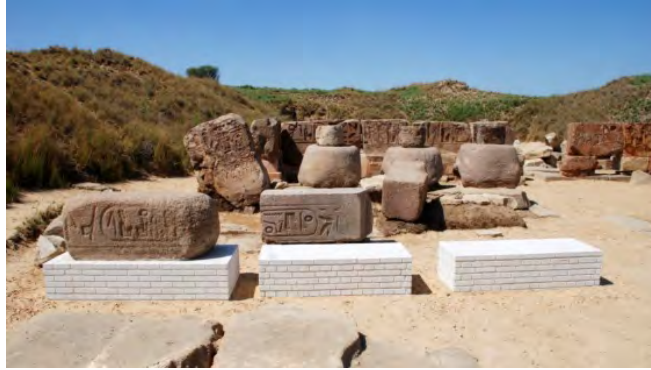
Built this year, in front of the column bases in the west, beside the pedestal for architrave 1 (Photo 34).

**Photo 34. Pedestals for architraves 1-3**

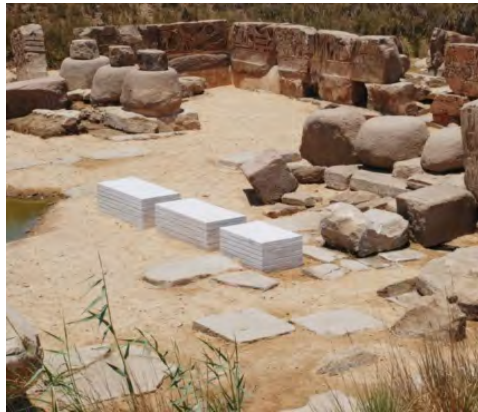
Built this year in front of the column bases in the east (Photo 35).

**Photo 35. Pedestals 4-6**

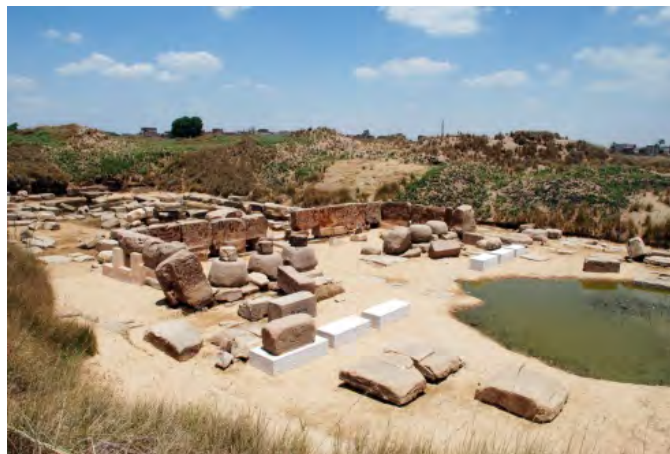
**Photo 36. Pedestals 1-6 for architraves**

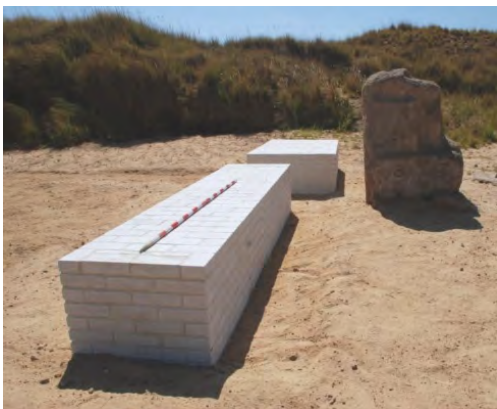
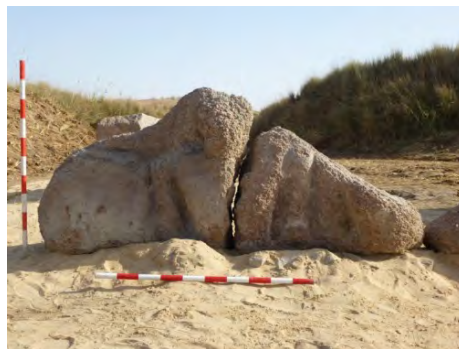
**Photo 37. Pedestals 7-8 for triad.      Photo 38. Triad- upper part**

The two pedestals already constructed have been placed behind the stones which formed the base for the sculpture. Excavation of the ground had previously been carried out to ensure that there were no archaeological remains. The two pedestals, located side by side are of almost the same dimensions, as they have been designed for the different measurements and weights of the sculptural fragments they are intended to support (Photos 37 and 38).

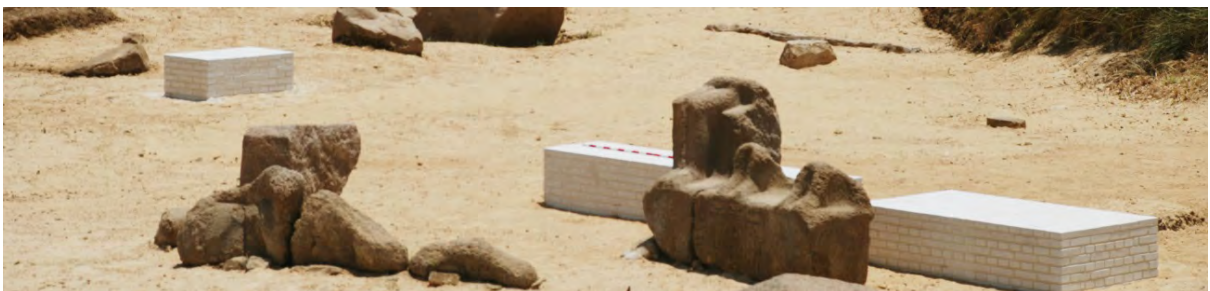
These pedestals 7-9 have been installed in the south of the Temple and the sculptures will be placed on them during the next campaign (Photo 39).

**Photo 39. Pedestals beside the sculptures.**
