**PRELIMINARY REPORT. EXCAVATIONS IN HERAKLEOPOLIS MAGNA
(Ihnasya el Medina, Beni Suef). Season 2014**

**by M. Carmen Pérez Die
and**

The work carried out during this campaign was focused mainly on **HERYSHEF TEMPLE:**

We present one exemple of work in the **WEST LATERAL PORTICO**

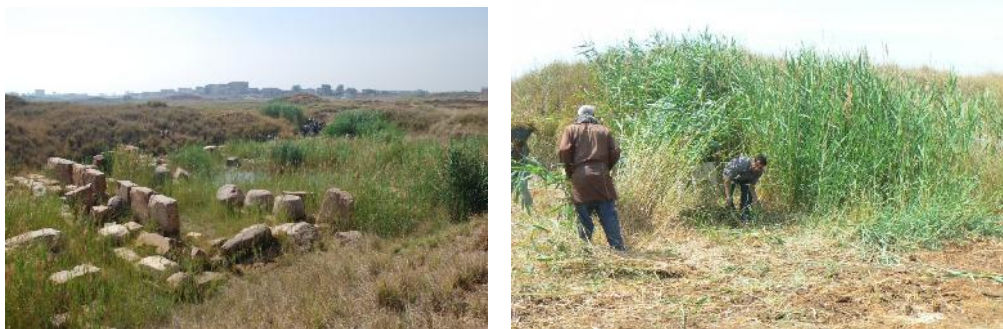
agricultural. On arrival at the site we found the monument flooded, with some zones completely inaccessible, such as the hypostyle hall and the sanctuary, and with nearly all the precincts covered with vegetation formed by tall stands of reeds (*Arundo donax*. Family :*Poaceae*). Thus, cleaning work had to be carried out at the start of the campaign to facilitate the access and mobility of the workers and machinery and improve visibility of the work zones

Heryshef Temple. Beginning of 2014 season and cleaning

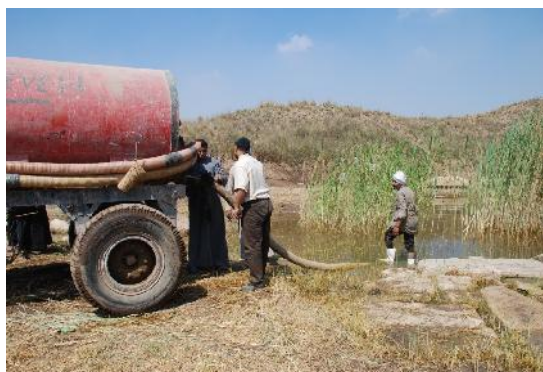
It should be noted that the desiccation project started by the SCA has not yet been completed. The water in this season was extracted by water tractors

Extraction of water table in the Courtyard of the Temple

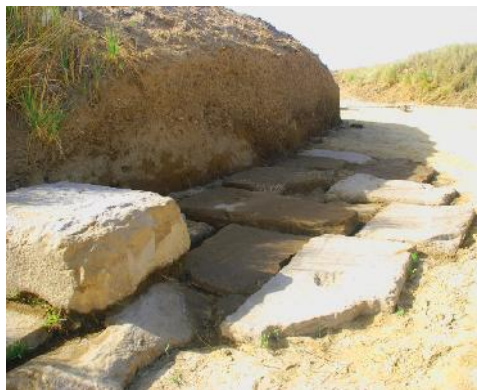
Limited by the E profile. Part of the paving of the courtyard is located here which had not been previously discovered. This was uncovered, revealing 11 slabs of large dimensions.

Paving of the Courtyard

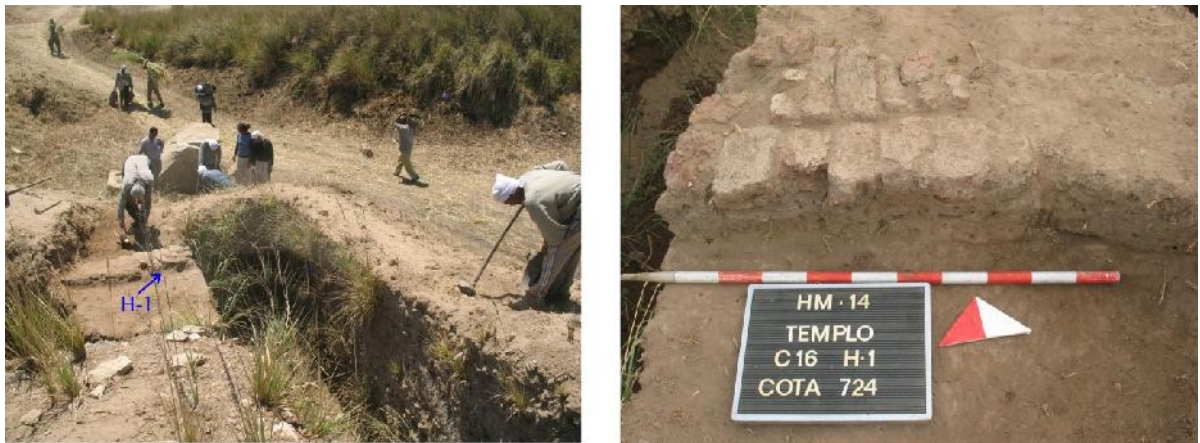
Square 16

These were excavated with artificial levels collecting the most significant pottery fragments. The layers are formed by more or less uniform fills sloping to the W: abundant earth and pottery fragments, a small white layer composed of small fragments of rock and another which contains fragments of pottery vessels.

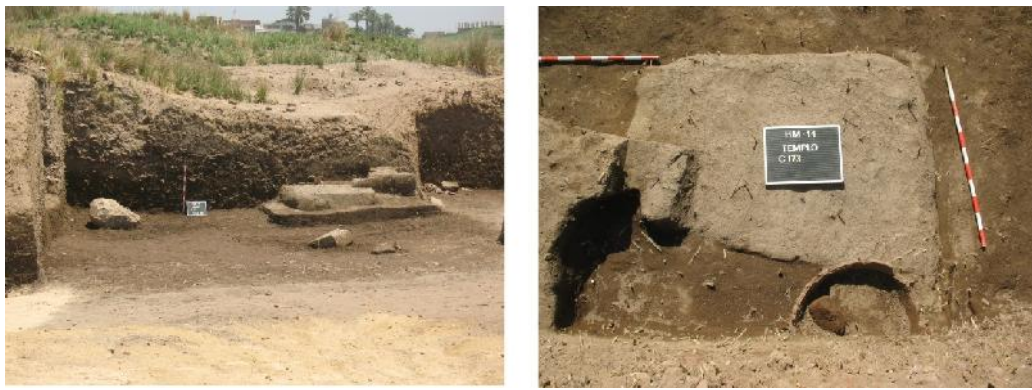
Square 173

In square 173, part of a rectangular adobe chamber roofed with a vault was found. Below the vault a very large pottery vessel was conserved. We have only explored one end of this possible chamber, as the rest has not yet been excavated.

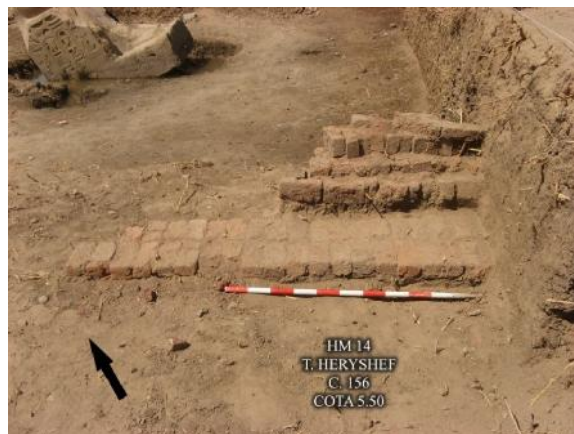
Square 156

Inn 156, the contiguous square to the S, a brick wall was found from the Roman Period but it could not be defined as it continued under square 157 where the excavation is not complete

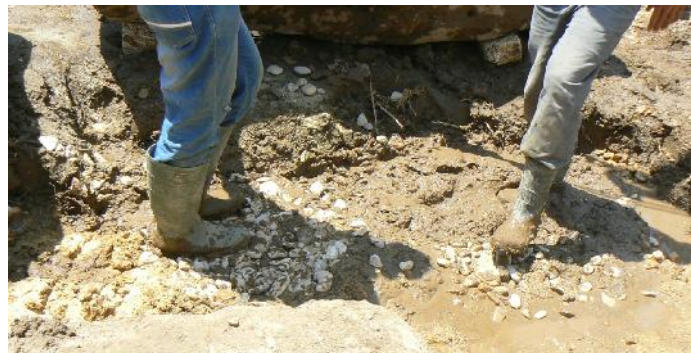
Fig. 33

Fabrication of hidraulic mortar

In the immediate vicinity of blocks 14 and 15 there is a hollow in the ground with a considerable accumulation of water; this year we found this zone very muddy and with abundant vegetation and refuse. To fill in this hole and before building a supporting wall for the ashlar of the W lateral portico, this zone was filled with a mixture of small and medium size pebbles, mud and sand to make the ground uniformly horizontal, so that it could be used as support for the architectonic complex. This hydraulic mortar, used in Egypt in other archaeological sites with similar problems of humidity, obtained a type of ground which provides strength and uniformity for the sub-soil

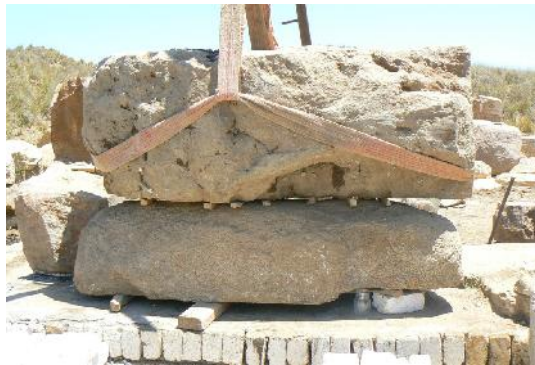
Blocks 14 and 15 relocated in 2014

This block was removed from the mud, raised up and placed on ashlar n° 15. A supporting base had previously been prepared with brick and cement, and wooden wedges were inserted between the two stones to allow the aeration of the whole group.

The state of conservation of this block is delicate, with abundant loss of compositional material. It was turned over and placed on a similar base to those described above and n° 14 was placed on top of it; the zones where there were no points of union between the two ashlar were consolidated and filled with small fragments of limestone, small pebbles, wood and mortar, also used to render the exterior

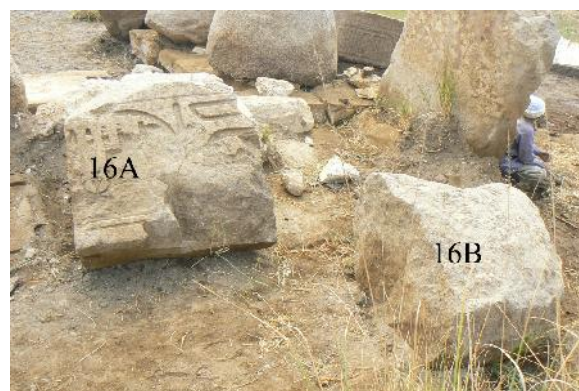
In 2013 both was broken and fallen down

Blocks 16 A and B in 2013

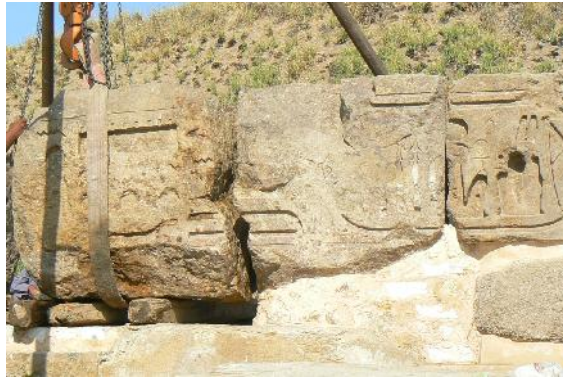
Blocs 16 A and B relocated in 2014

The movement and relocation of the two fragments which form this block were carried out in a similar way to the rest. To place it at its original height in line with n° 14 which conserves hieroglyphic inscriptions required the provision of a supporting base to protect it from humidity. This support base is the continuation of the base corresponding to blocks n° 14 and 15. All the blocks were in the same line

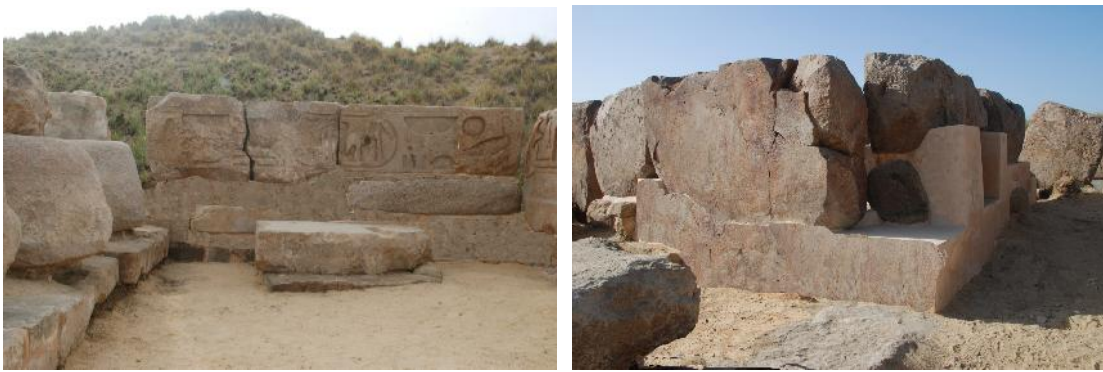
West lateral portico in 2014. Front and back

Due to the enormous weight, to the instability of the zone behind it and to avoid future movements or displacements, vertical walls had to be built to act as buttresses to support and reinforce the inferior and posterior part of the whole group ; the system of production and the materials used were similar to that of the rest of the support walls of the portico.
