## **SPANISH ARCHEOLOGICAL MISSION in HERACLEOPOLIS MAGNA (IHNASYA EL MEDINA, BENI SUEF). 2017 Season**

### **THE TEMPLE OF HERYSHEE**

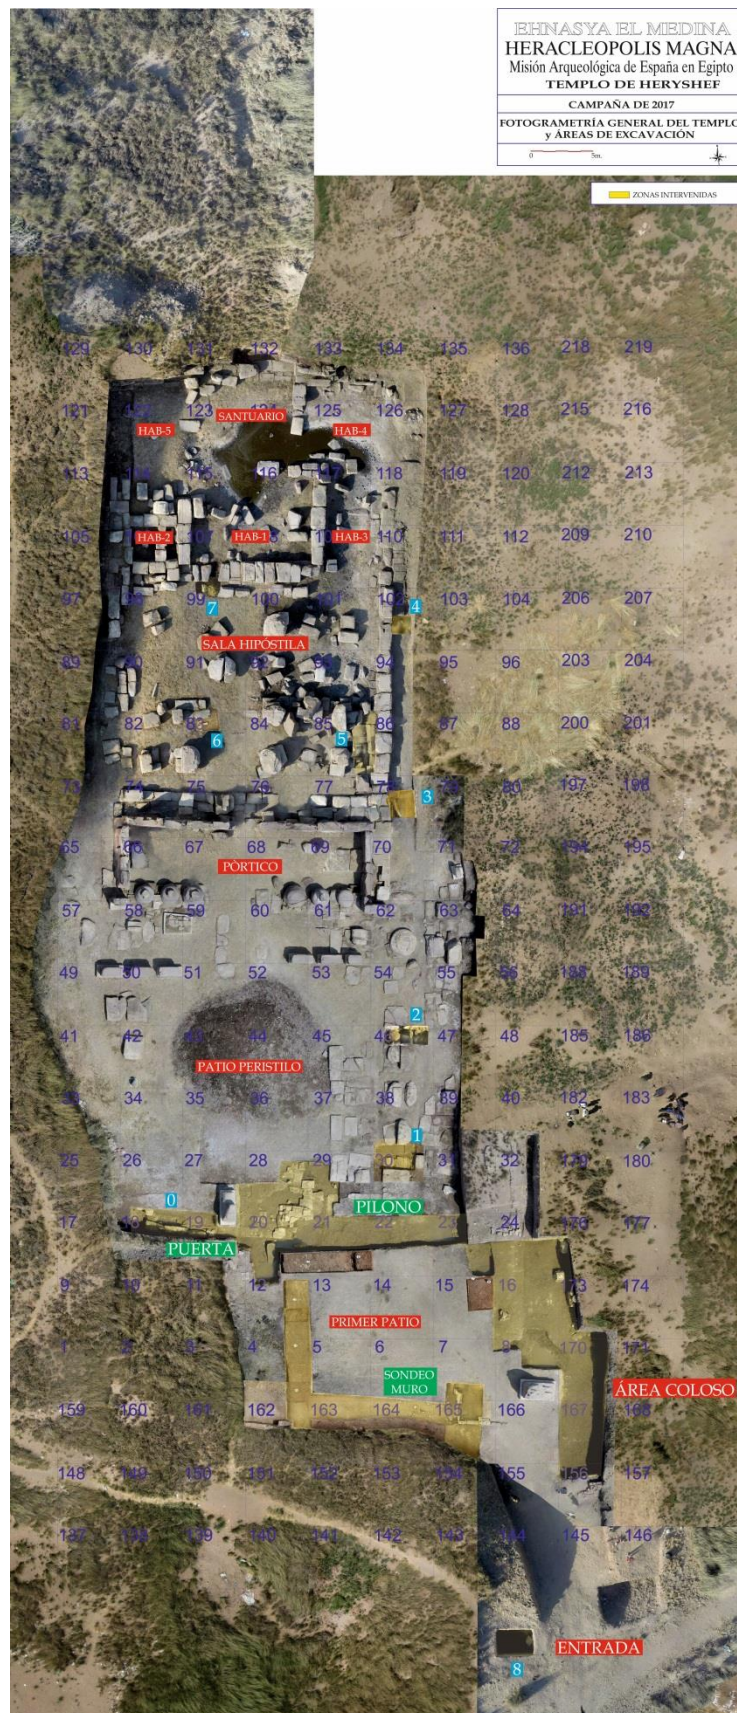
Fig. 1. Aerial photogrammetry of the temple.

The temple has several rooms (Fig 1): First open court, peristyle court, portico, hypostyle room, rooms and sanctuary.

**2.3.5. Works of photographic and aerial documentation:** (Fig. 8). High-quality photographs were taken using a kite. The photos obtained have been used to create a photogrammetry of the temple area (Figure 1).

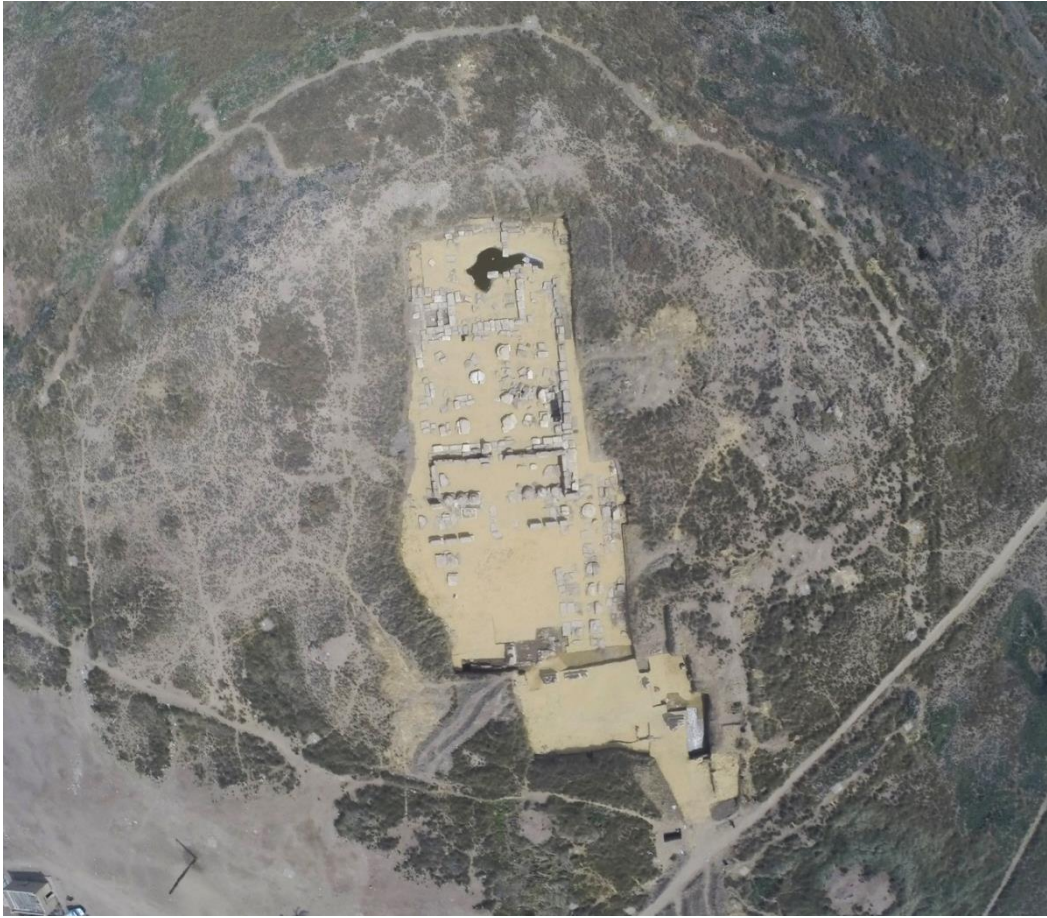
Fig 2. Surveys 1,2,3

**2.2. Documentation system, by means of Digital Photogrammetry.** Planimetry is achieved through 3D models generated by different computer programs, and from them orthophotos are obtained: elevations, sections, profiles, etc. (Fig 2). The use of a kite with a camera, allowed us to obtain aerial views and to develop an aerial Photogrammetry of some areas of the Temple (fig 3).

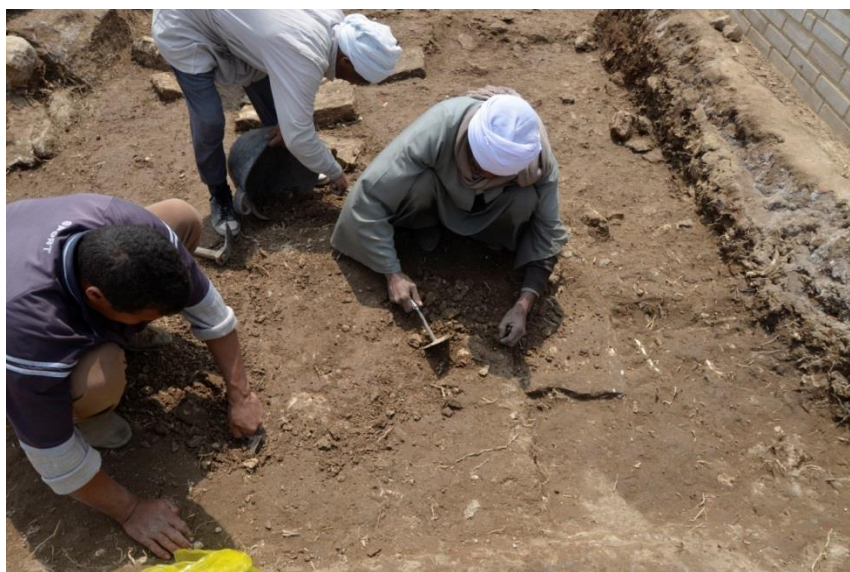
Fig.6. Profile south of the excavation

**2.3.3 Profile Analysis Works:** (Fig. 6). Determine the exact location in the profiles of the land extracted in the excavations of Petrie or Naville. It has been made in the east and south profiles of the First Patio.

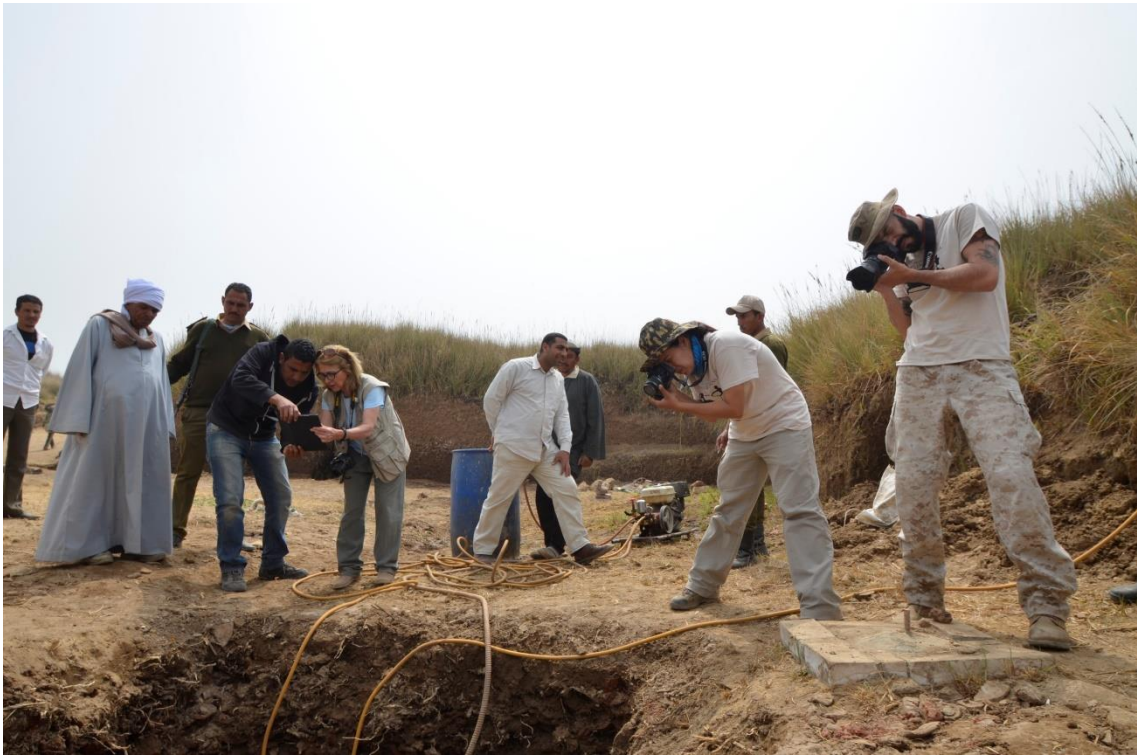
Fig.7. Excavation Works in front of the pylon

**2.3.4. Manual excavation:** (Fig.7), isolating the archaeological material in order to establish a historical sequence.

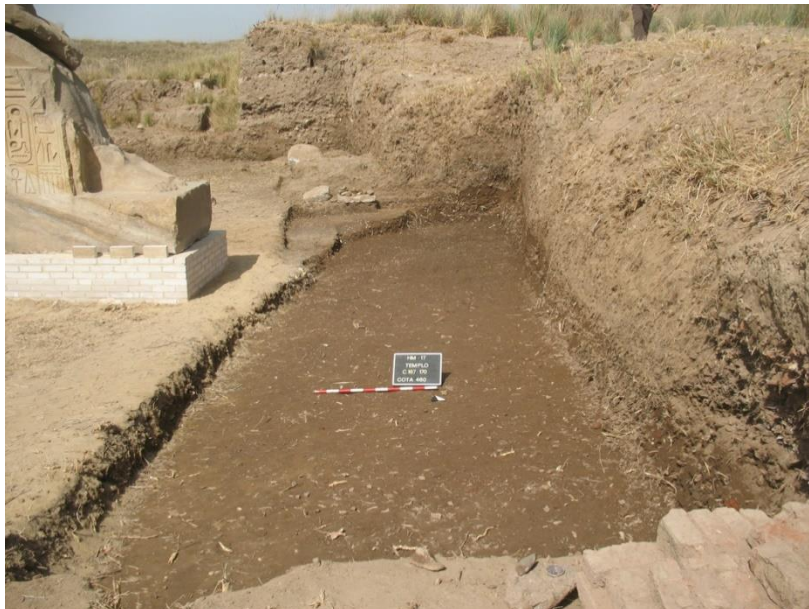
Fig.9. Squares 167 y 17

The lower part of the Colossus of Ramses II is located in this area (Fig. 9). The objectives have been:

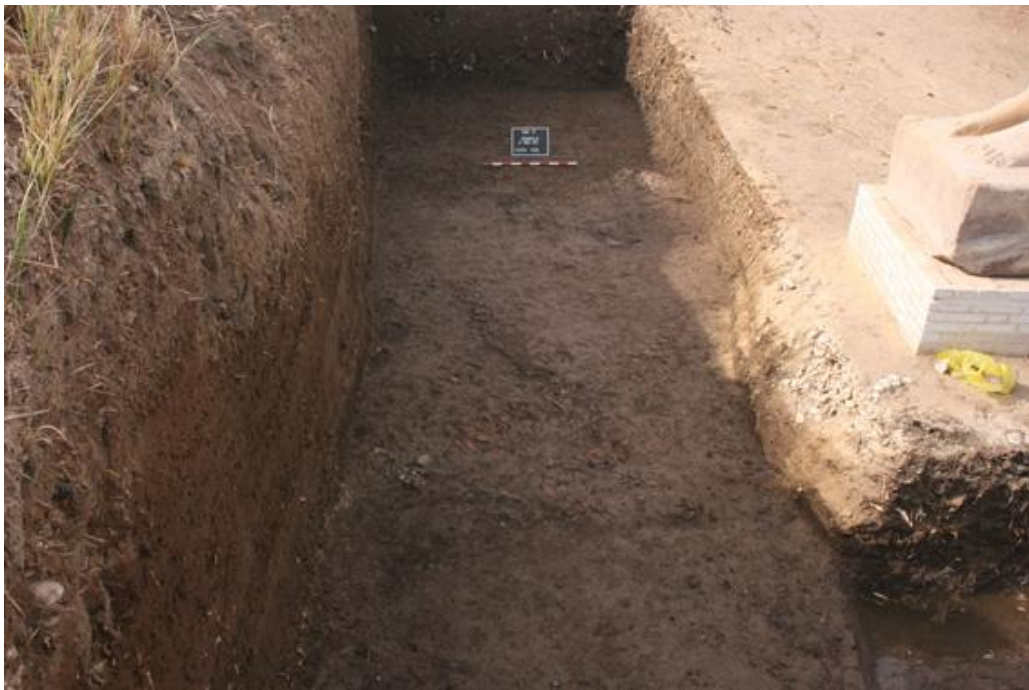
Fig.10. Squares 167 y 170, pottery

Work began at the feet of the colossus, at the southeast edge of the temple. In the first levels, a large number of pottery fragments were found, mostly dating to the LA7 (Late Amphora 7) chronology (Fig. 10). We also found some fragments of Aswan Clay type ceramic, a fragment of painted pottery (which appears in the 5<sup>th</sup>-6<sup>th</sup> centuries and also in the 8<sup>th</sup>-9<sup>th</sup> centuries)

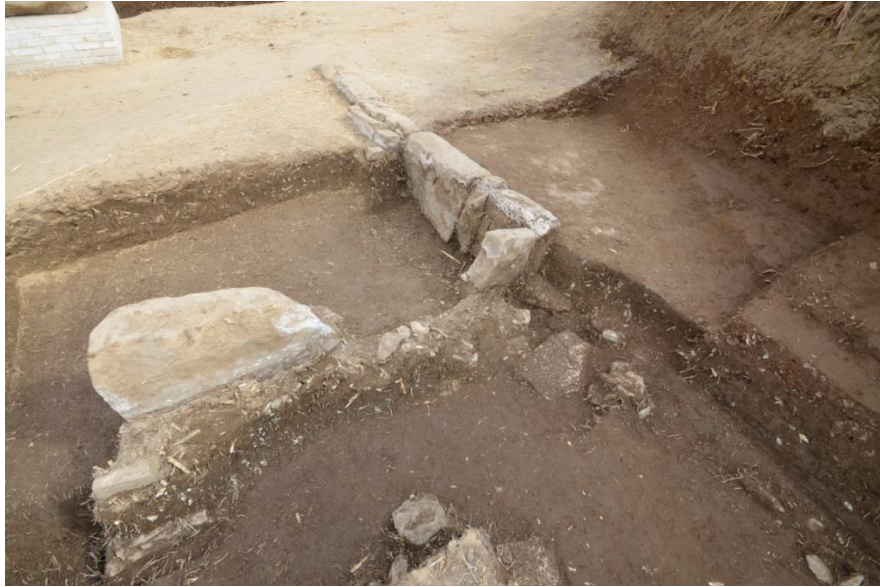
The remains of a stone chapel were found behind the colossus. This structure is associated with the cult of the statue of Ramses II and, within it we found a multitude of Roman pottery terracotta, surely arranged there by the pilgrims who came to worship the statue of Ramses II (Fig. 12).

Fig.12. Small Chaple

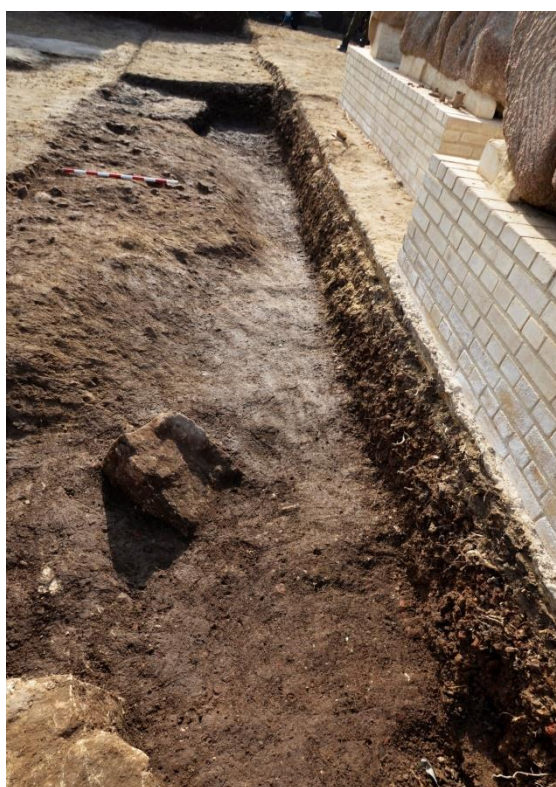
**3.3.1.1. East Side of the Pylon** (Fig. 14). We have been able to verify the massive plunder that the east side of the Pylon suffered, since we have found an enormous empty pit, without stones. It is 14 m long and 3 m wide and it extends from west to east, from the access door of the Pylon to the east side profile. The width exceeds 7 m, with a depth of 1.20 m.

Fig. 14. Peristyle Court. Oriental side of the Pylon.

In addition, we have been able to locate **the foundation pit of the pylon** with strata dating to a time previous to the construction of the Temple. Large quantities of late Roman pottery have also been recovered.

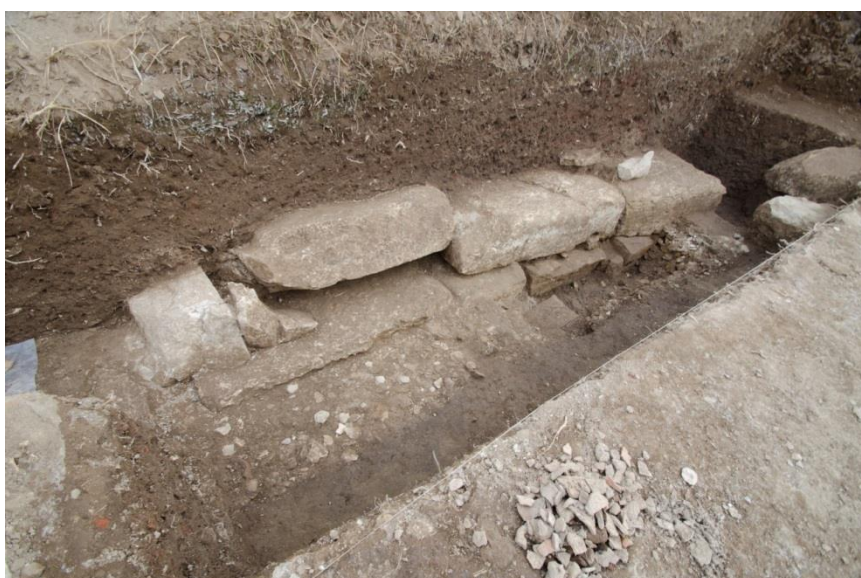
**3.3.1.2. West side of the Pylon** (Fig. 15). The structure of the west side of the Pylon presents a better state of conservation, despite the crack in its western end.

In order to build the Pylon, a large pit was excavated. The stone blocks of the foundation were placed inside, in at least two overlapping rows. The lower row shows smooth slabs carved and reused and the upper row, large ashlar. Over these two rows we found large blocks: the upper face of these is engraved with the line that indicates the location of the Pylon's wall.

Fig.15. West side of the gate and big foundation of the pylons.

We cannot determine the dimensions of the pylon, but we can assume that it should have been about 36 m in length and a width of about 9 m.

The pit opened to place inside the stones of the pylon contains some ceramic remains, such as containers to make bread that can be dated between the Middle and New Kingdom, thus assuming the pylon was constructed at this time.

Finally, as is the case on the east side, a process of massive plundering of the blocks and ashlar at the top of the pylon has been documented. The material recovered in the pit allows us to date this plunder maybe to Roman times.

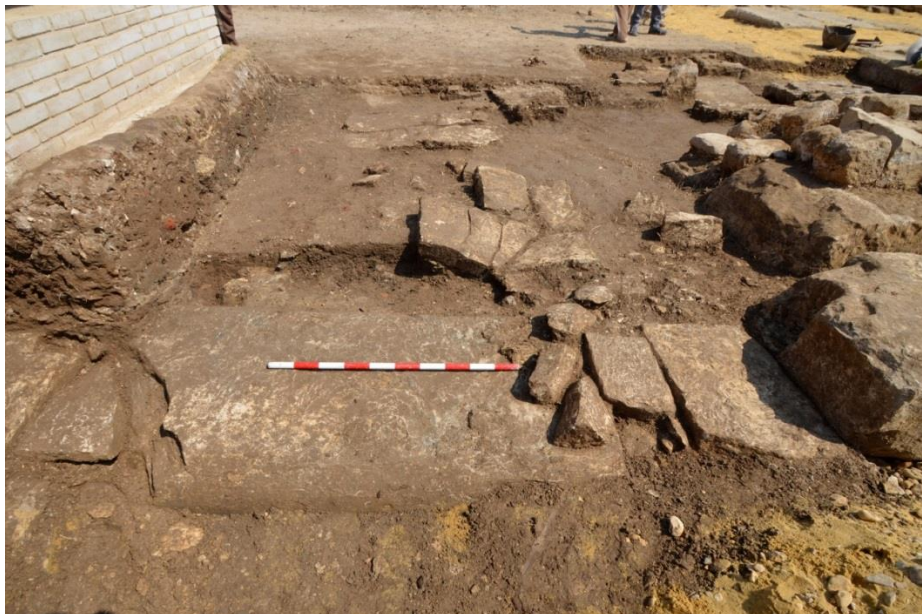
The gate has at least two phases: based on the ceramics, it was built in the Middle Kingdom or beginning of the New Kingdom, whereas the remodelling would have taken place in the late Roman period (Fig. 16).

Fig.16. Gate of the pylon

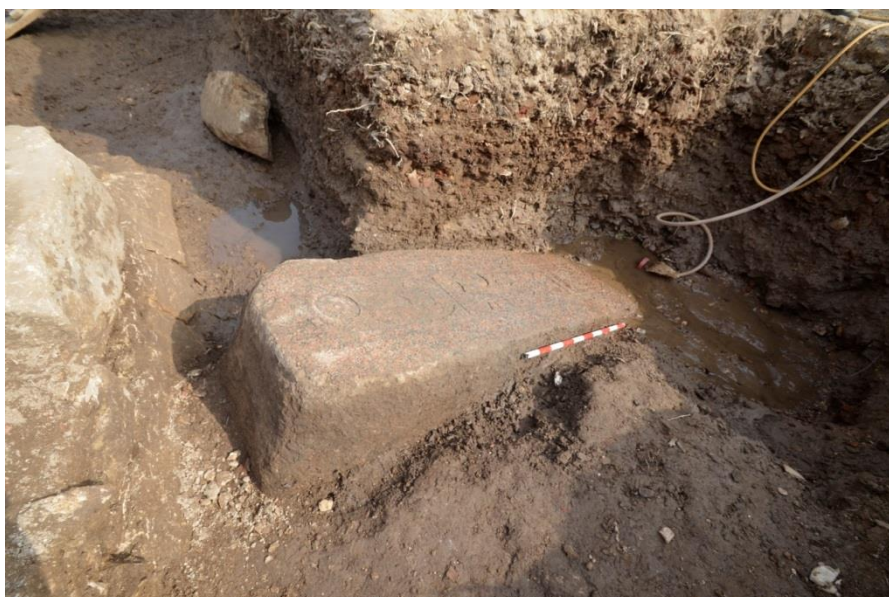
On the other side of the pit is a red granite lintel from Senusret II. This may indicate that this pylon, erected in ancient times, was dismantled in the Roman period (Fig 17).

Fig.17. Fragment of architrave of Sesostri II.

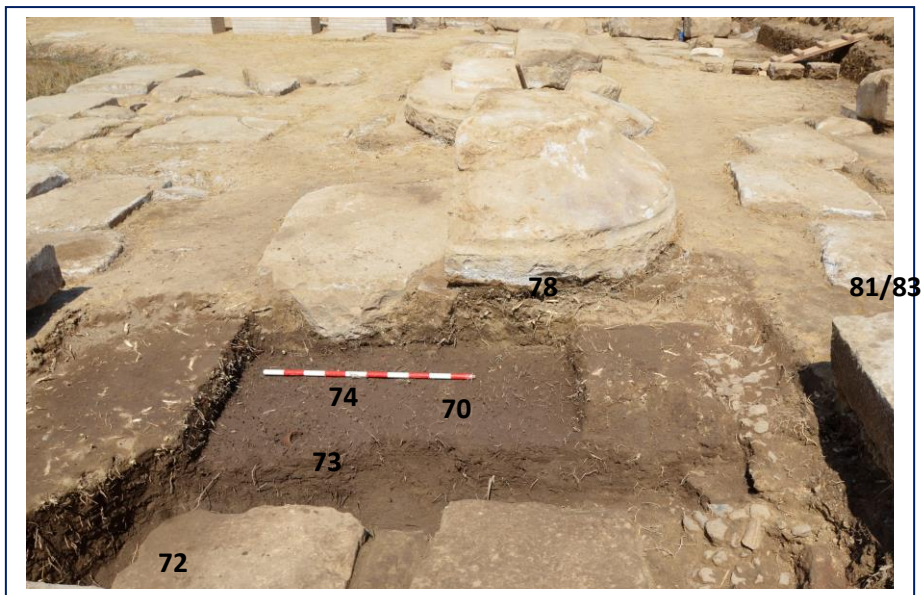
Fig.19. Survey 1

Survey located on the east side of the Peristyle Patio, between the first and second columns of the southeast end of the Patio. We have been able to verify how the columns of the peristyle patio, now disappeared, were constructed. All columns have the same foundation system: a well of circular or quadrangular plant was excavated, inside which two rows of overlapping slabs were placed and oriented in the opposite direction. The well and the slabs of different thicknesses were filled with sand, which served as a levelling system,. Two semi-circular stones that form the base of the column were placed over them. The well has a depth of about a meter and the base exceeds 0.60 m.

The material recovered in this well system can be dated to the New Kingdom, Allowing us to date the column to this period.

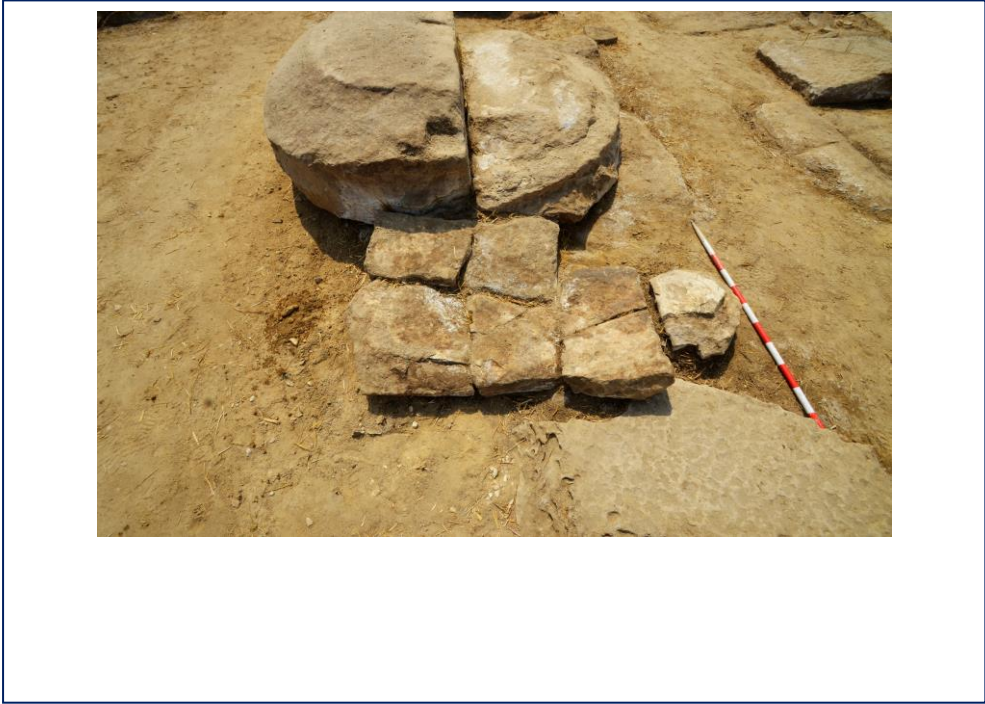
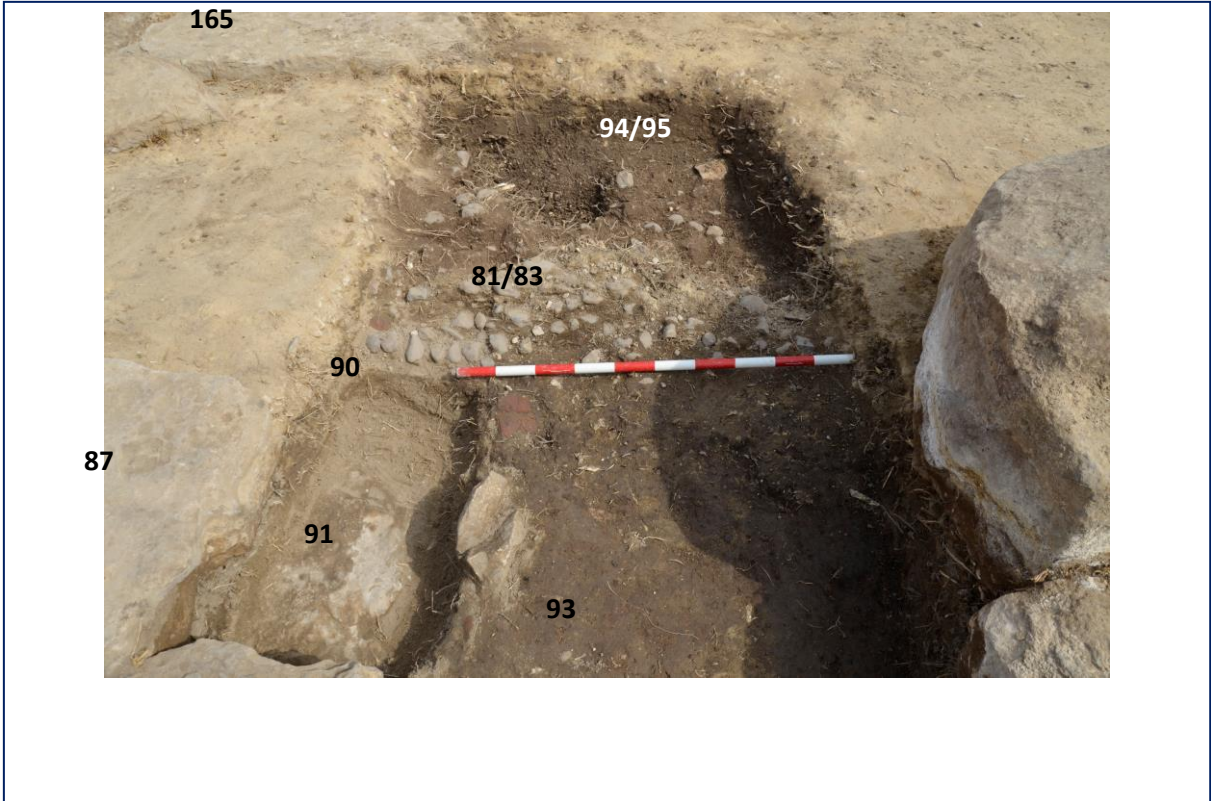
Fig.20. Survey 2

The survey was carried out in the Peristyle Patio. The floor is covered with a series of stone slabs, between the two columns. The analysis of the filling seems to indicate a very late (Roman) chronology for the level of the floor.

The pottery associated with the foundation pit of the columns is quite abundant, ranging from the Second Intermediate Period to the beginning of the New Kingdom, previous to Thutmose III.

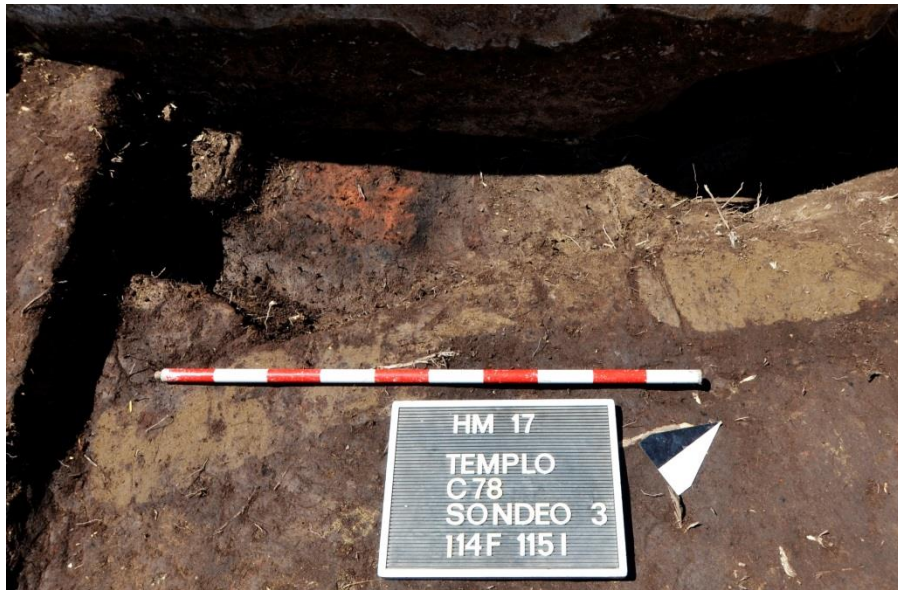
Fig.22. Survey 4

Survey 4 is located on the outer wall of the eastern temple closure. We have cleaned the surface layer and the different units, in levels with a depth of 50 cm in which we have documented Roman and late period ceramics, until reaching the water table level of the temple. This survey has not provided conclusive data.

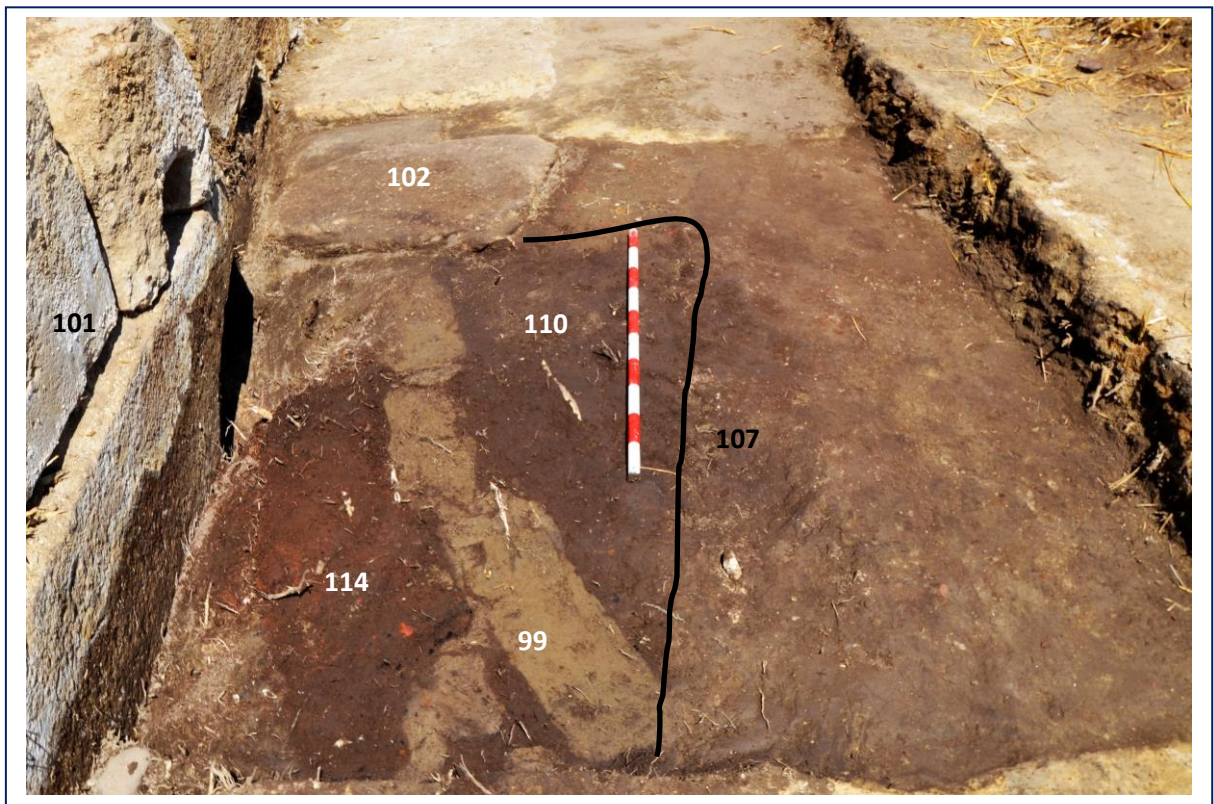
Fig.23. Survey 3

The survey was carried out between the outer NE corner of the limestone wall surrounding the Portico and the Hypostyle Room. The results obtained in this third survey have allowed us to detect the most complete chronological sequence in all surveys. We have documented, as well, intact levels and dwelling structures, prior to the construction of the temple walls, and hints of the existence of major religious building reforms, once the walls were constructed.

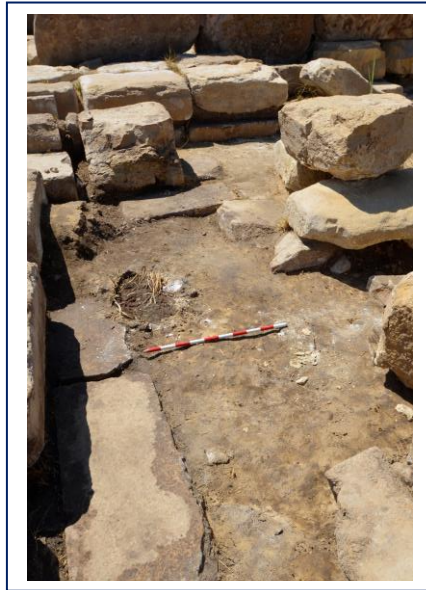
Fig.24. Survey 5

This survey took place in the SE corner of the Hypostyle Room. We have been able to analyse the subsoil of this room and the constructive system of its walls and columns. Different constructive moments have been detected, some of which have been dated due to the recovered ceramic material.

1.- First filling: This filling can be dated to the beginning of the New Kingdom, before Thutmose III.

2.- Second filling: The material is homogeneous and can be situated between the Middle Kingdom and New Kingdom.

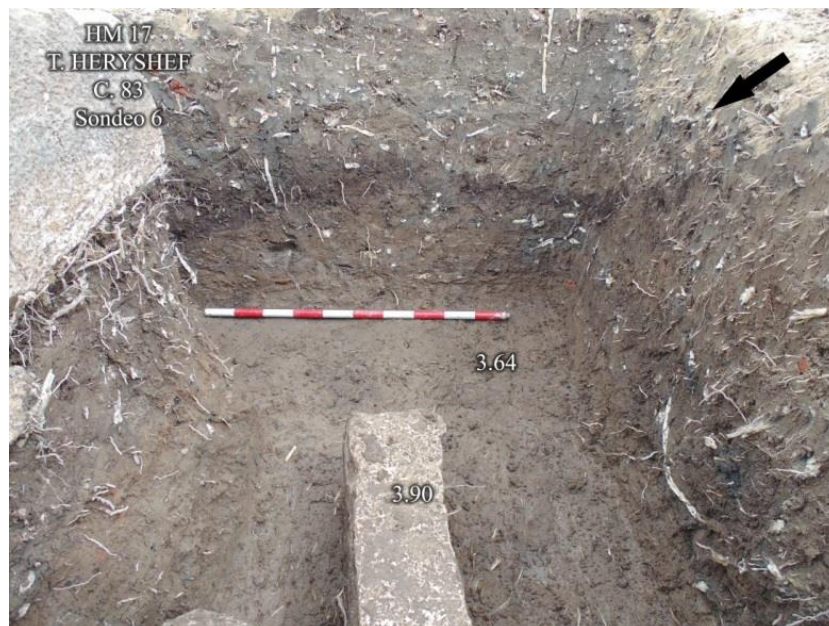
Fig.25. Survey 6

This survey was performed in the centre of the hypostyle room, where the level was lowered 90 centimetres reaching the water table. In this survey we have found material from different chronologies, some of which seem be dated to the Middle Kingdom, although classification and confirmation are still pending.

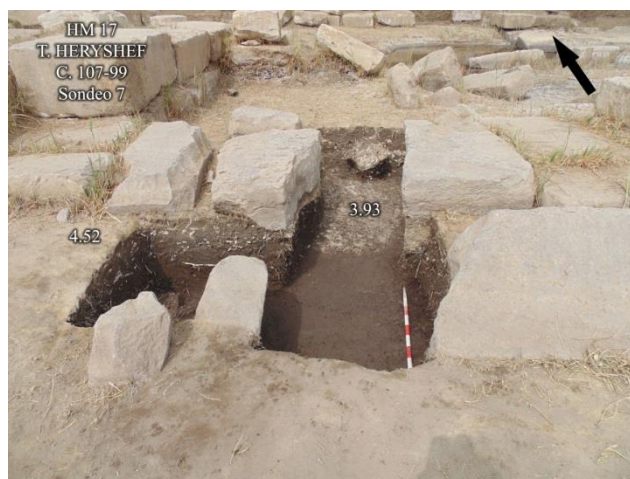
Fig. 26. Survey 7

Survey 7 is located between the hypostyle room and room I. The soil level has been deepened to a total of 60 centimetres until the water of the water table rose exposing a large slab of foundation. The material found seems to indicate a New Kingdom chronology.

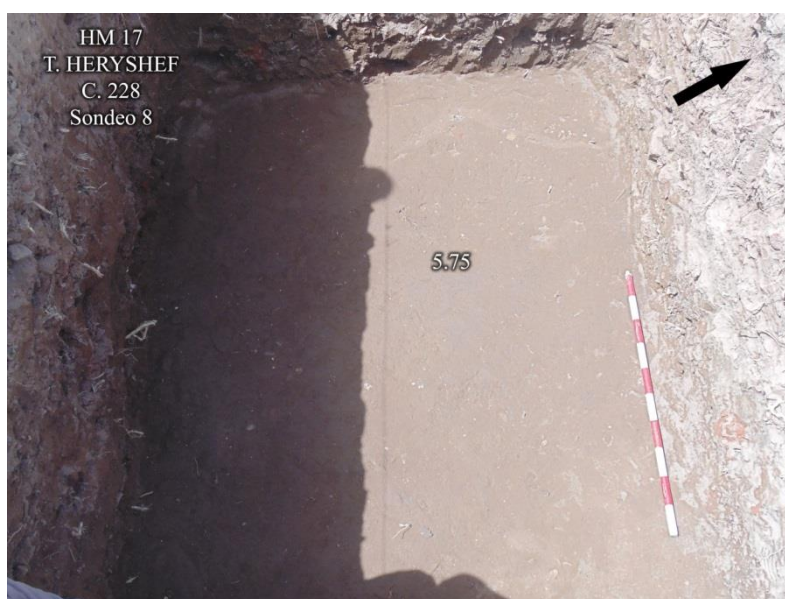
Fig.27. Survey 8

Survey 8 is located in the area of the current entrance to the temple. This survey has yielded no results, and only late Roman materials such as a ceramic amphora have been documented, at a shallow depth.

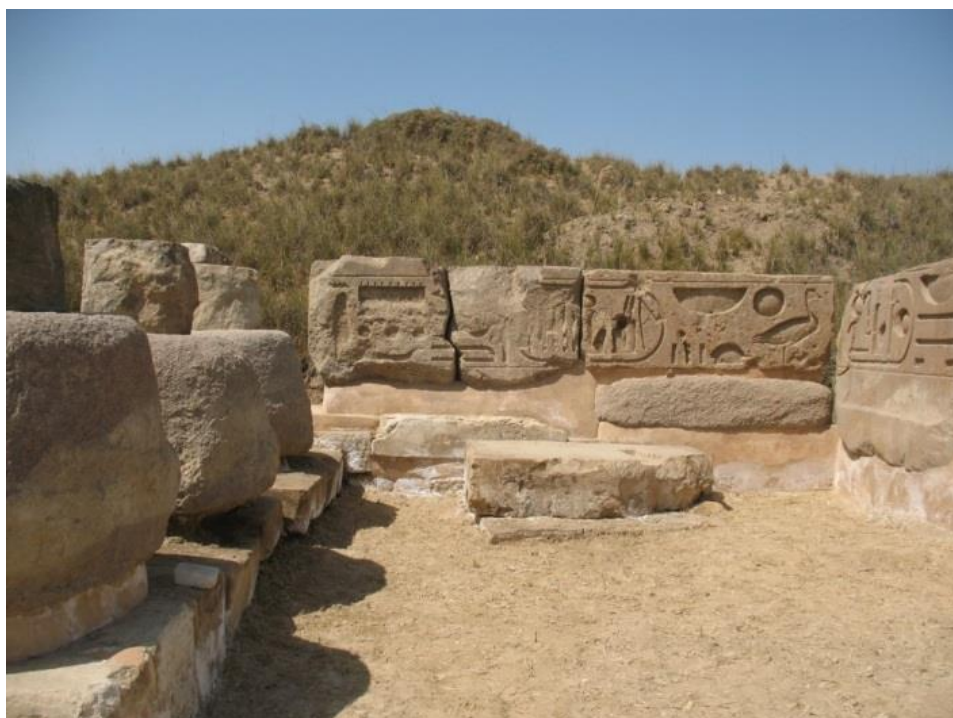
Fig.28. Portico. East side

A small ladder or ramp would give access to the portico, with the floor at a higher level. The background walls of the portico have survived and there are inscriptions relating to the *heb-seb* festival of Ramses II as well as the bases of the columns, found by Naville and distributed in different museums around the world. Two colossi of the Middle Kingdom reused by Ramses II would be located on the East-West walls.

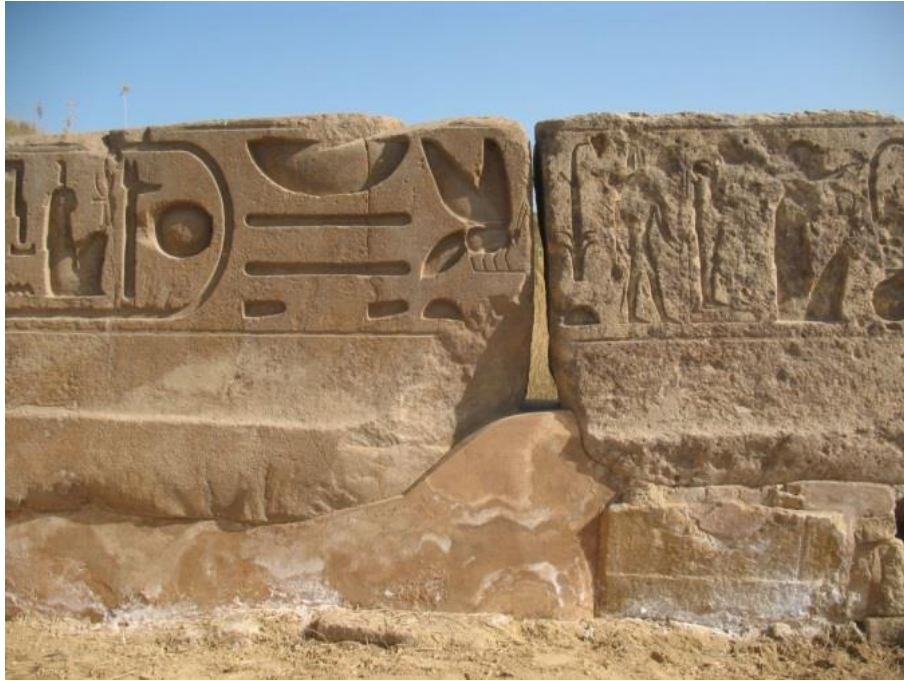
Fig.29. Portico. West side

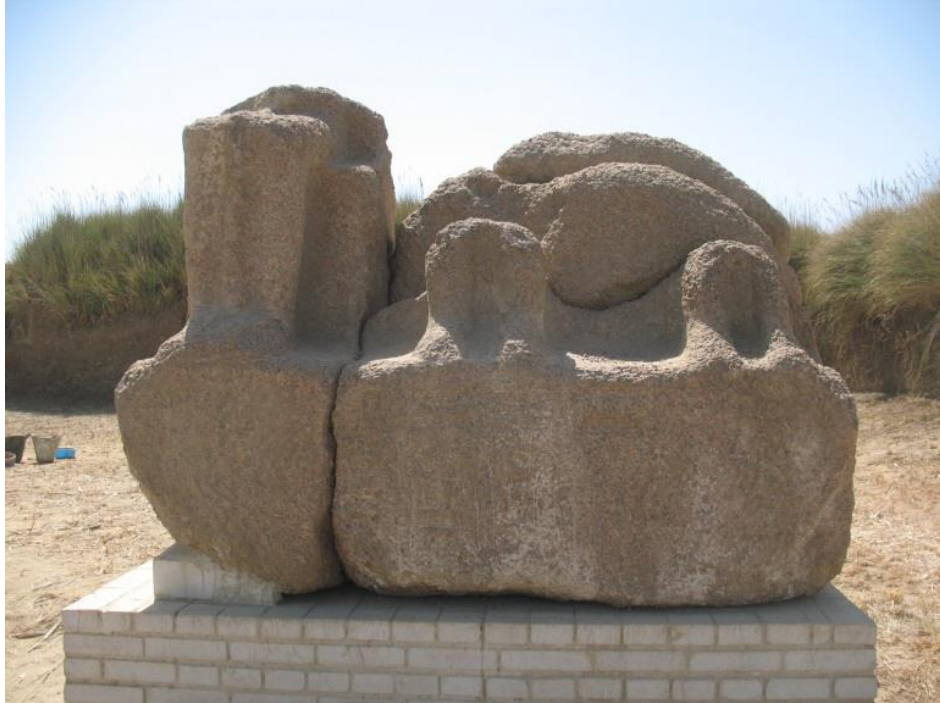
Fig.31. Basis of the columns

A door gives access to the hypostyle room, which is much deteriorated and only some of the bases of the columns have been preserved. Further north another room, also with columns, would precede the sanctuary and the rooms of the boats and the treasure.

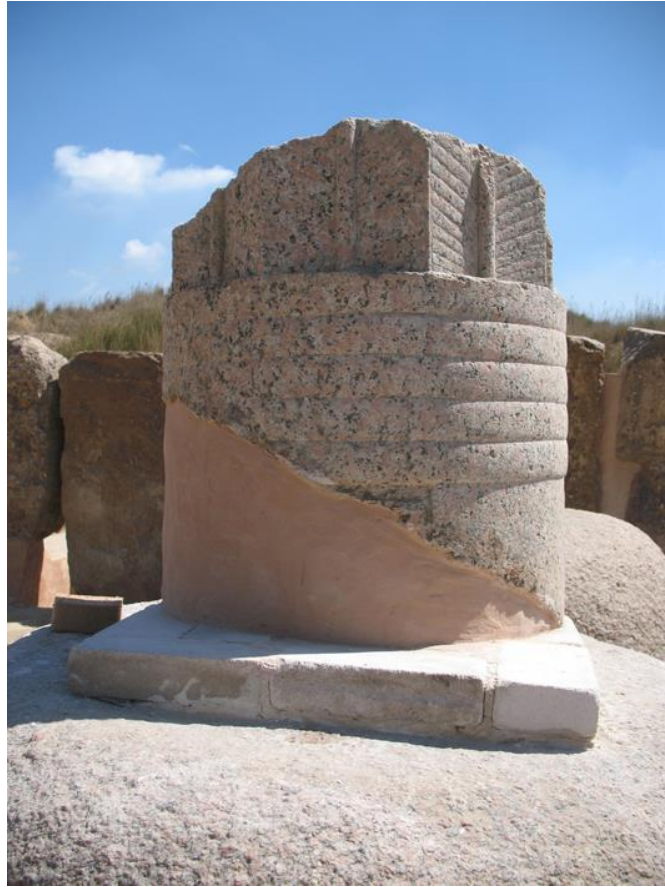
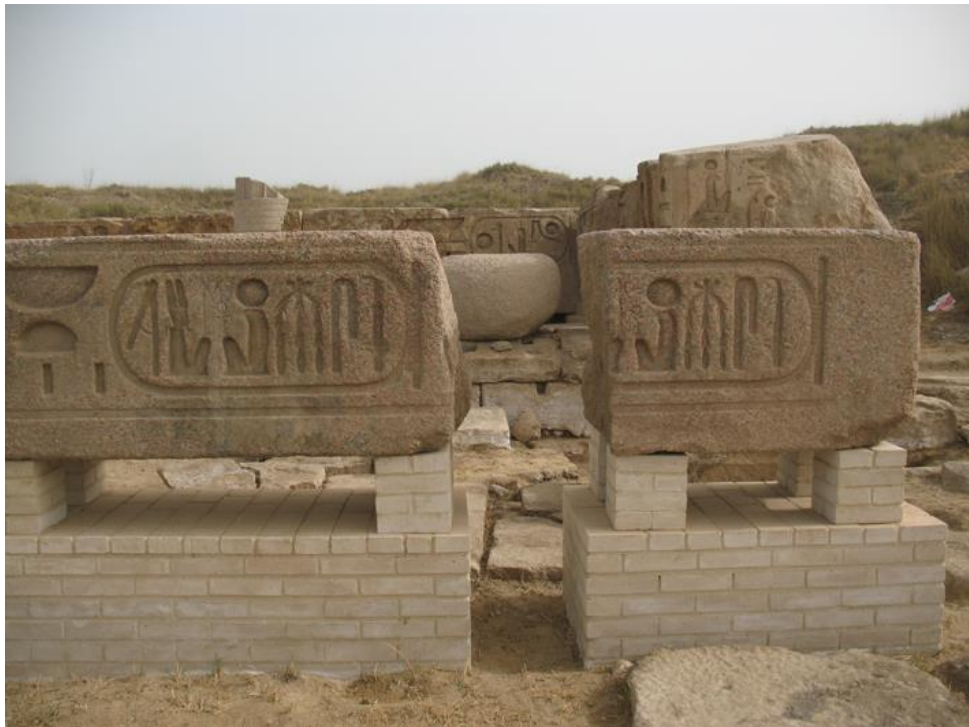
Before applying the mortar, a second plastic insulation layer was placed. The capital was placed in its location wedged with blocks of limestone.

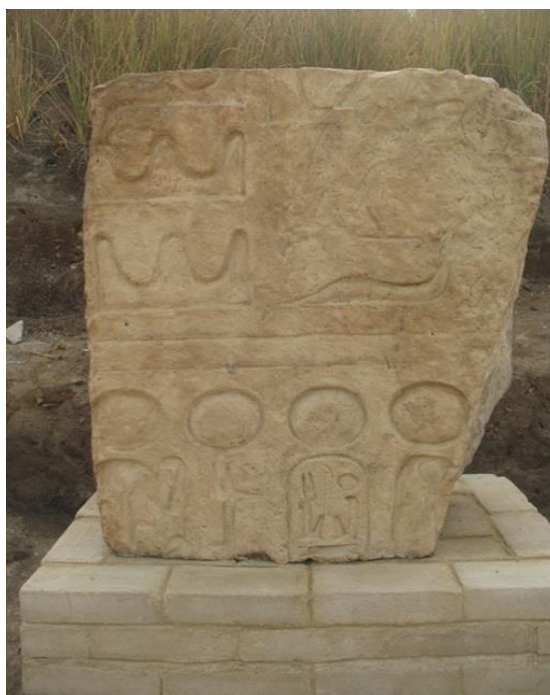
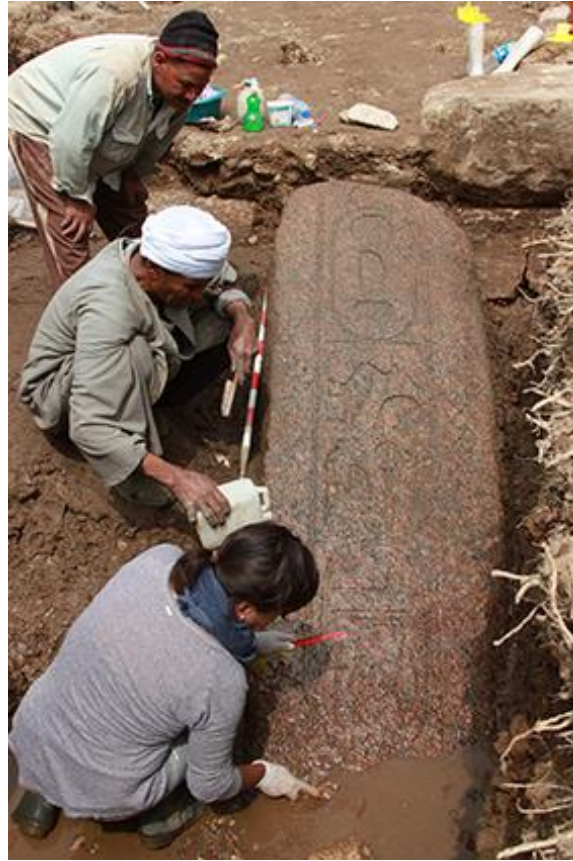
The restoration treatment has consisted on the removal of the thick layer of wet mud that covered the whole block. Subsequently, we have eliminated the soluble salts, by applying, to the entire surface of the inscription, paper pulp pads and distilled water. Once the treatment was finished, it was placed on a base made in the same way as the rest of the bases in the temple, to isolate it from the soil moisture.

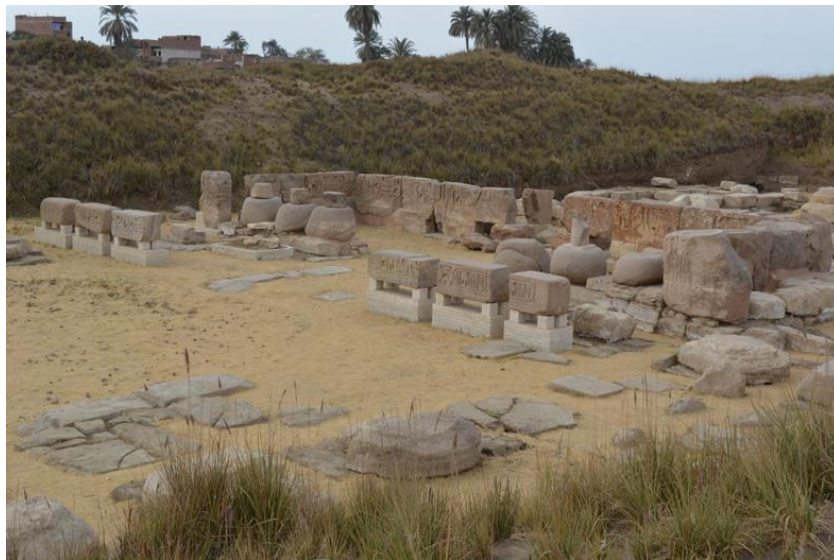
Fig. 66 General View of the Peristyle court

The Temple is oriented North-South and consists of: a **first open patio** that would give way to the **pylons**, preceded by the two statues of Ramses, of which only the bottom part of one is left, and is currently displaced on the side East of the first patio. This year we found the foundations of the stone pylons. After crossing the pylons, one arrives at the **peristyle patio**, but none of the columns or the royal statues has survived. On either side of the pylon there would have been a triad, one kept at the Cairo Museum and Fragment of the other one remain in the Temple .

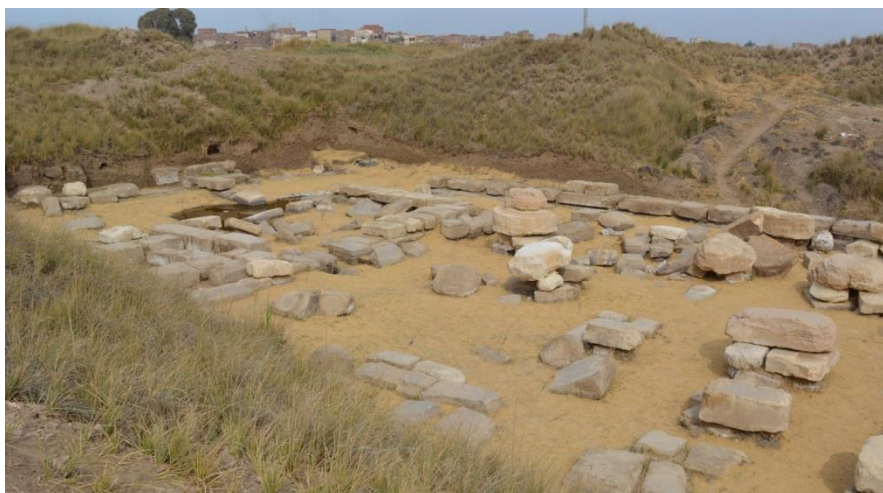
Fig. 67. General View of the Portico
