Terminado
REPORT OF THE SPANISH ARCHAEOLOGICAL MISSION AT
HERAKLEOPOLIS MAGNA (EHNASYA EL MEDINA SITE)
BENI SUEF. SEASON 2022

Maria Carmen Pérez-Die, Antonio Gómez, Antonio Guio, Antonia Moreno
and Taysyr Mohamed

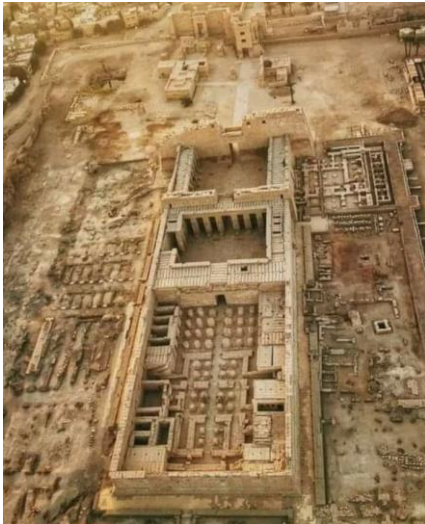
Medinet Habu. Temple of Ramsés III .

Dimensions of the Pylon: 75,5 x 11,5 m.

Length = 6,5 times his Width).

Material: Sandstone.

Chronology: Ramsés III (1185 – 1153 a. C.)

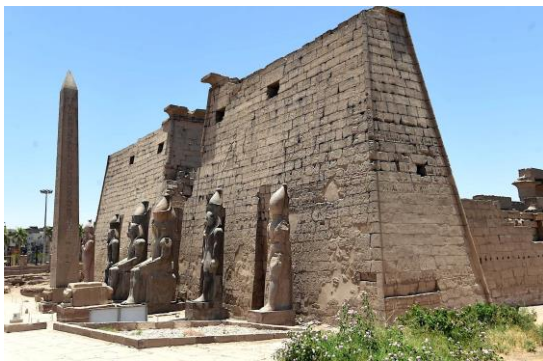
Amon Temple. Luxor

Dimensions of the Pylon: 65 x 9 m.

Length = 7,2 times his Width

Material: Sandstone.

Chronology: Amenofis III, Ramsés II (1400 - 1000 a. C.)

- 1.- Avenida de las esfinges
- 2.- Capilla de Serapis
- 3.- Capilla de Hathor
- 4.- Obelisco y estatuas sedentes de Ramsés II
- 5.- Gran Pylon
- 6.- Capillas de Amón, Mut y Jonsu
- 7.- Patio solar de Ramsés II
- 8.- Columnata procesional (Amenofis III)
- 9.- Patio solar de Amenofis III
- 10.- Sala Hipóstila
- 11.- Sala de Mut
- 12.- Sala de Jonsu
- 13.- Sala de Amón
- 14.- Santuario romano
- 15.- Cámara del nacimiento (Amenofis III)
- 16.- Sala de ofrendas
- 17.- Santuario de la barca (Alejandro Magno)
- 18.- Vestibulo
- 19.- Santuario (Amenofis III)

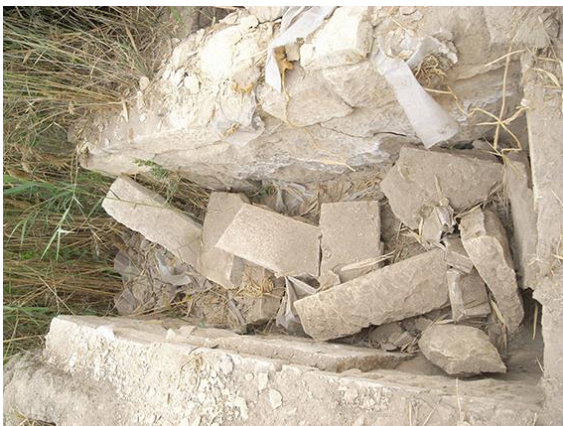
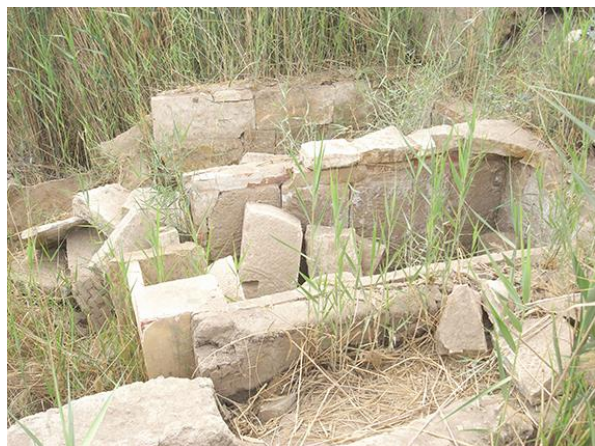
Necropolis of Third Intermediate period After Revolution. Ceiling of the tomb fallen down

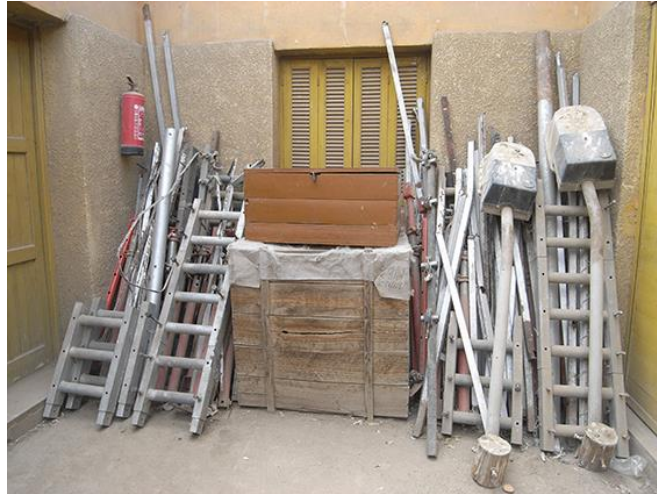
Necropolis of Third Intermediate Period After Revolution, supports of ceilings of tombs
